# THE ARUP JOURNAL

SEPTEMBER 1966

# Defects and remedial work for new wharf at Littlehampton

# The Meeting House at the University of Sussex

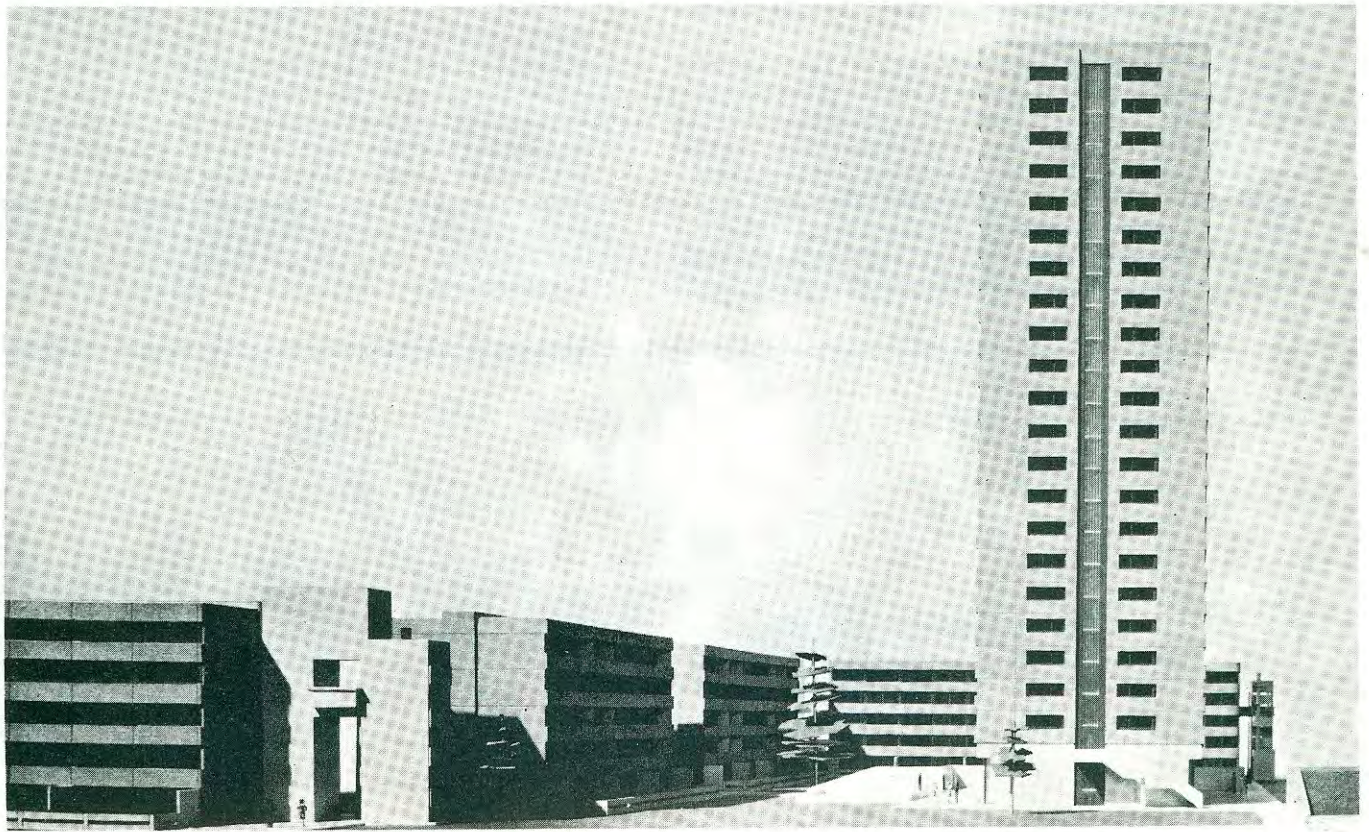
Fig.1. above  
 King Edward's Road Mixed Development  
 in system building  
 (Photo: Henk Snoek)

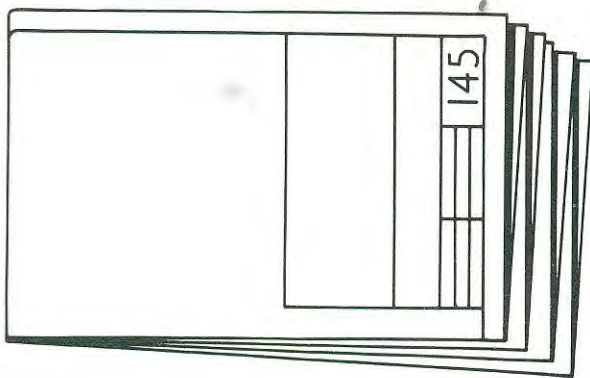
Fig. 3.(continued on facing page)

Normal drawing

Now consider just the paved area on the terrace of a typical house. It is to be constructed from standard precast slabs. A normal drawing (fig.3) would be drawn to show the required layout, sizes and details of all the slab units to be used, together with the necessary construction joint of slab to slab - in fact, a comprehensive drawing sheet

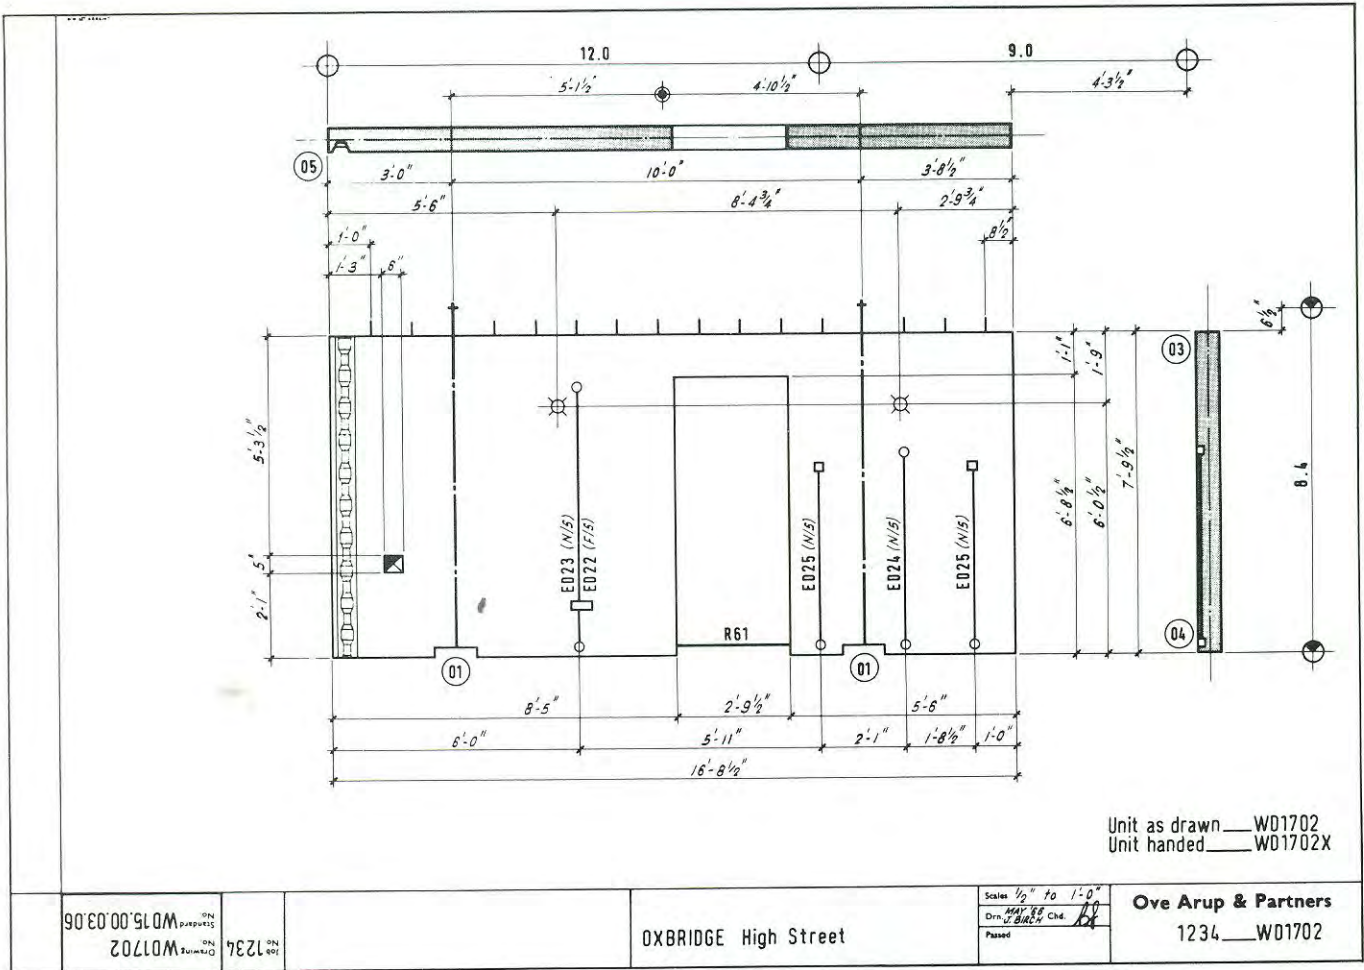
Fig. 4. above  
Typical component drawing

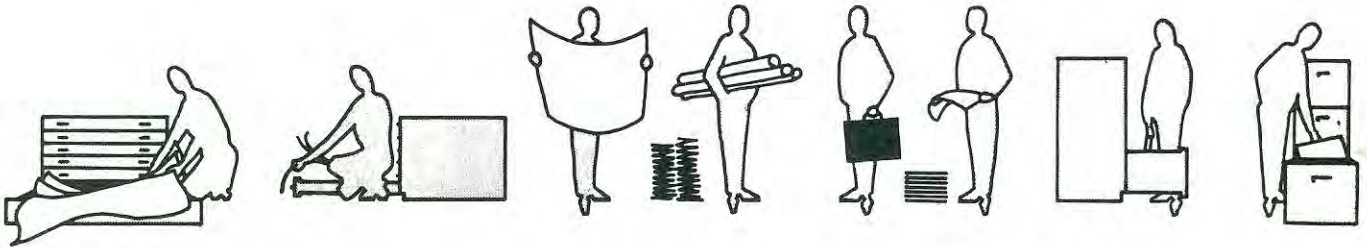
Fig. 6 above  
Advantages of small drawings

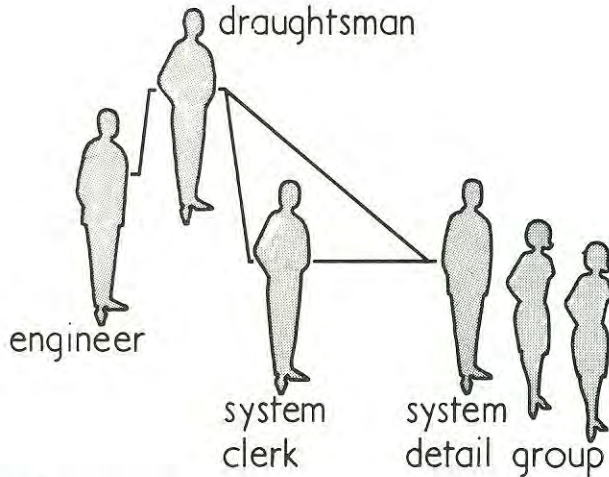
Fig. 7  
Pattern of group working

A pattern of group working is shown in figure 7. A job engineer has a draughtsman who processes the work into a 'draft' form. This will be a small job complete in itself, that is, self-explanatory, using the drawing shorthand methods. Having work that can be easily put into small job lots helps with the programming of work. The drafts are then passed to a 'system clerk' who books in, records programming requirements and performs other similar non-technical administrative duties.

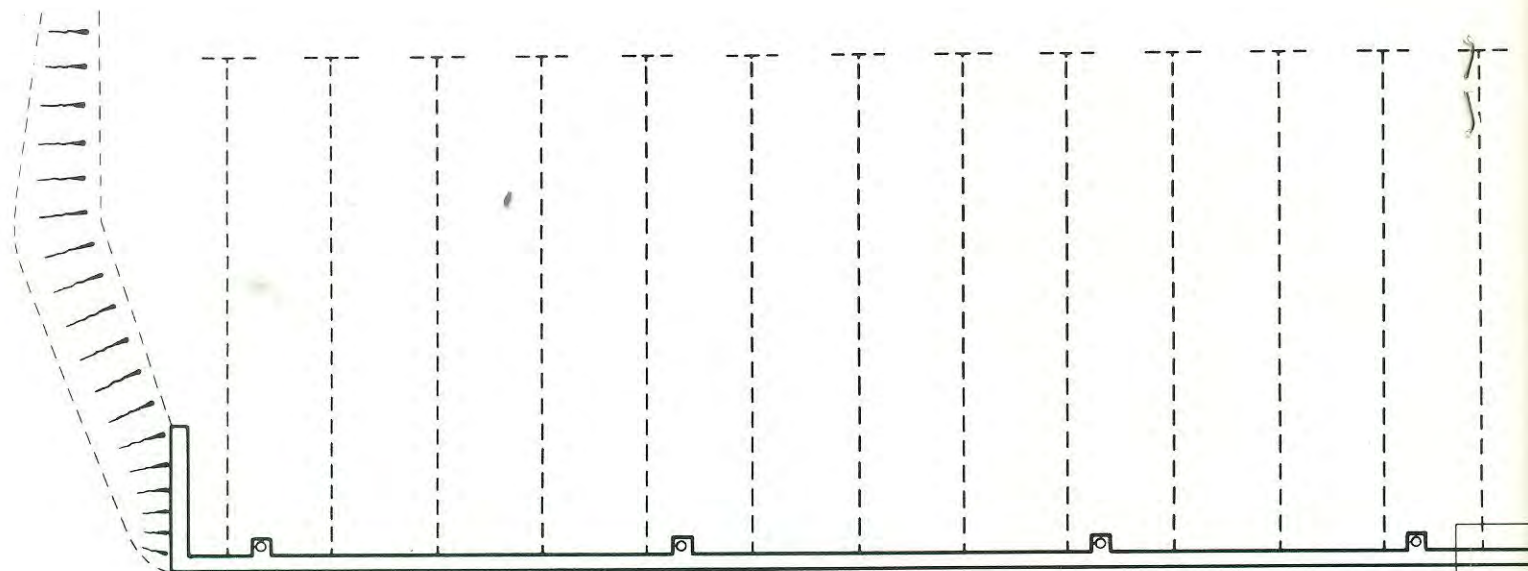
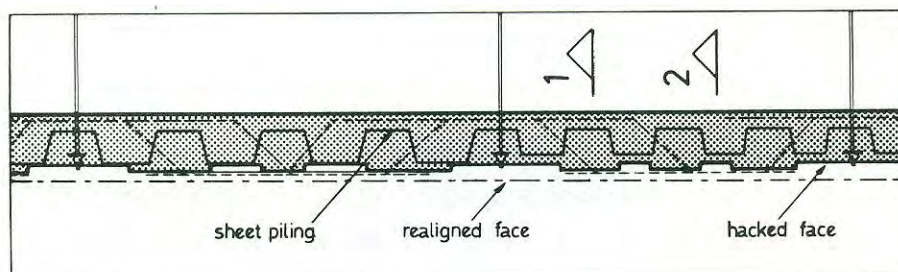
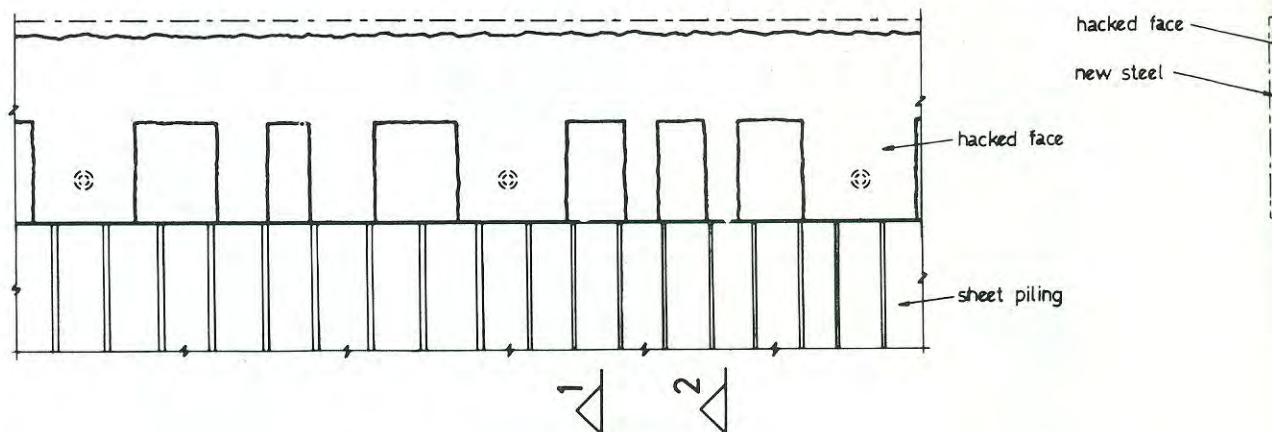
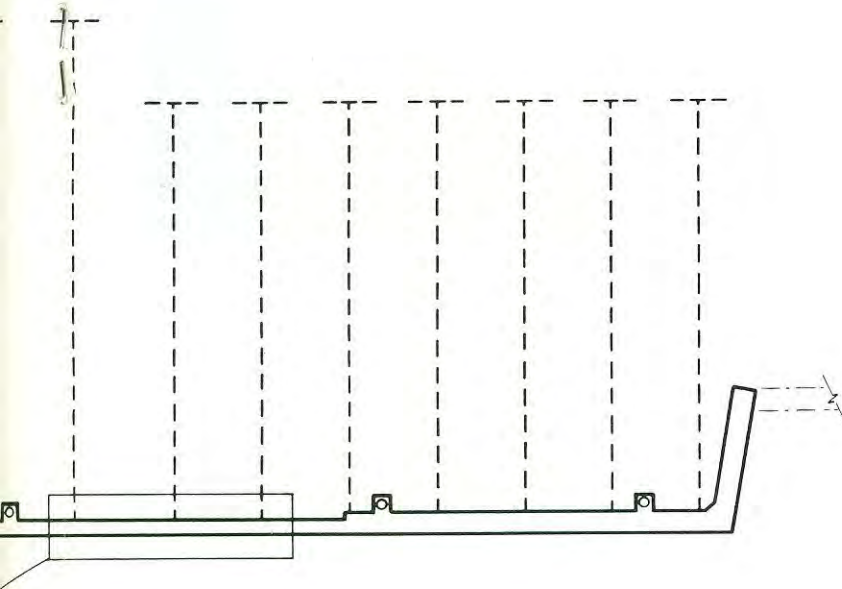
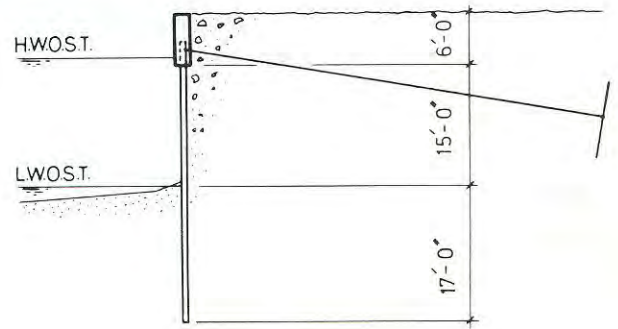
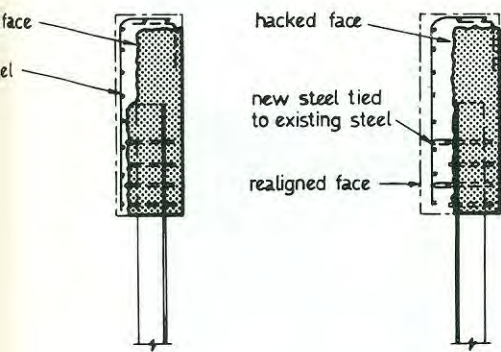
Fig.1  
Key plan and section; beam remedial work details  
Illustrator: Marion Raine

The recommendations include the construction of a new reinforced concrete top and external face to the capping beam, fully bonded with the existing sound material. The general contractor, who is located in

All honeycombed concrete, both on the top and the vertical faces of the capping beam was broken out to the sound concrete below and renewed.

For the length of the beam which was misaligned, the honeycombed areas on the outside face were hacked back to solid concrete. The areas which were not honeycombed

were also hacked to give a roughened face thus ensuring a good key for the new facing concrete. Along this complete length the existing reinforcing steel was exposed at least every 2 ft. to enable new reinforcement, which was part of the new facing concrete, to be tied back to it (fig. 1). The outside vertical face and top section were reinforced with longitudinal steel and L stirrups, both being tied to the existing steel at intervals. New facing and topping concrete was cast lining up with the outside face of the straight section, thereby giving a true line throughout the whole length of the beam. The new facing extended for the full depth of 6 ft. of the capping beam with a minimum thickness of 8 in. to permit proper consolidation. Where a crack occurred in that part of the capping beam where the vertical face was not honeycombed, the concrete was cut out to the full extent of the crack together with any unsound concrete on either side. This section was then recast. During this operation the beam was unable to take any load at that point. Therefore, rather than propping it, which might have proved difficult, the backfill was temporarily removed for 10 ft. on either side. Where cracks occurred in the honeycombed section of the vertical face of the beam, or in the misaligned section, they were automatically rectified by the work carried out in the remedial work for these latter defects.

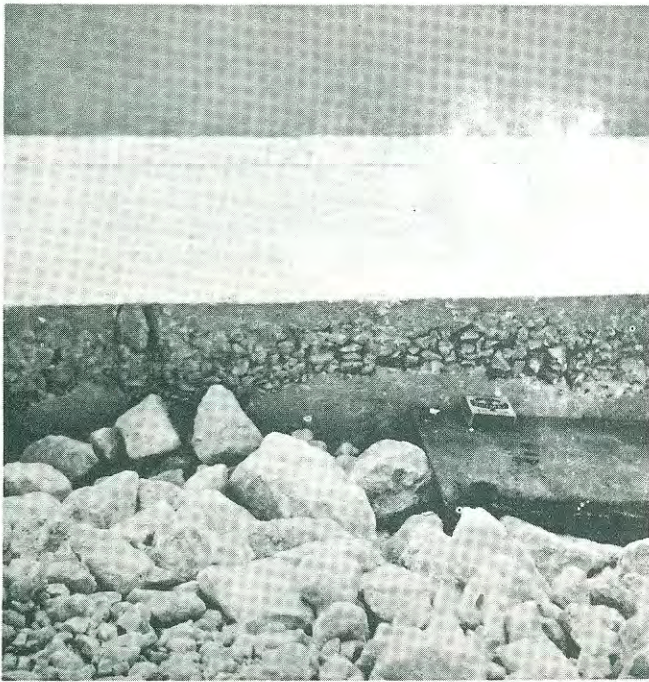
Fig. 2  
Honeycombed concrete at top of capping beam

A fifth of the length of the reinforced concrete beam had been cast approximately 4 in. below the required level. This last 4 in., poured after the main beam had hardened, was not consolidated, nor had the previous face been hacked and cleaned to receive it. The result was a porous joint with 4 in. of honeycombed concrete on top (fig. 2). Further honeycombing occurred on both vertical faces of the reinforced concrete beam for a half of the remaining length of the wharf (figs. 3 and 4). This porous concrete extended to the full depth of the cover.

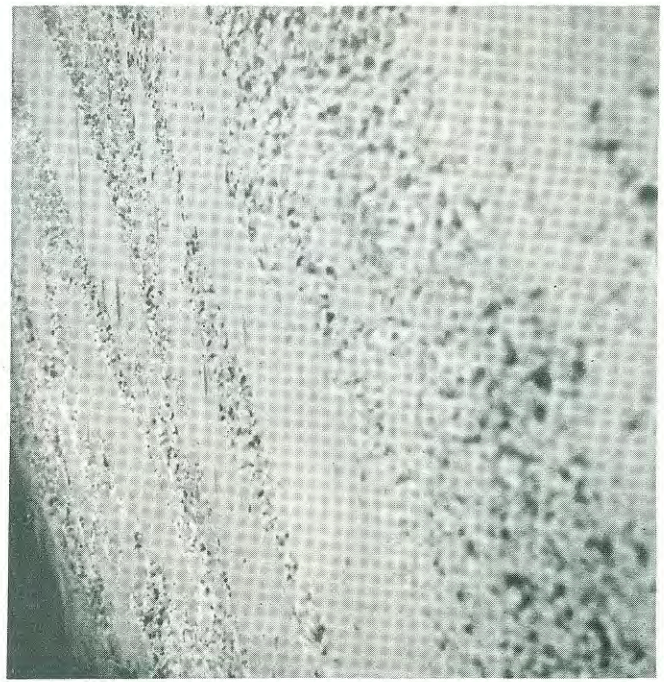
Fig. 3  
Honeycombed vertical face of capping beam

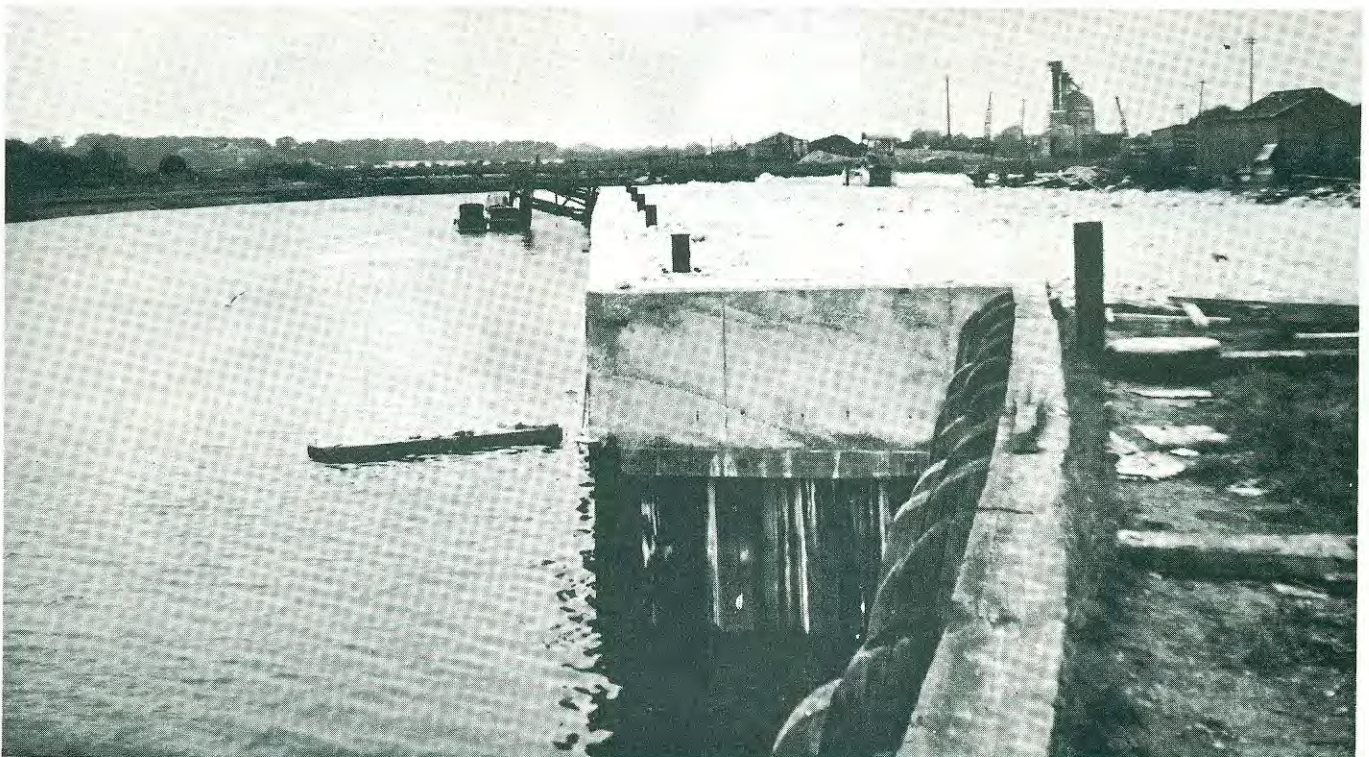
Fig. 4  
End elevation of wharf looking west

The reinforced concrete beam was not cast straight in plan. A kink in the beam occurred near the centre of its length, making this point project 5 in. from a straight line joining the east and west ends of the beam (fig. 4).

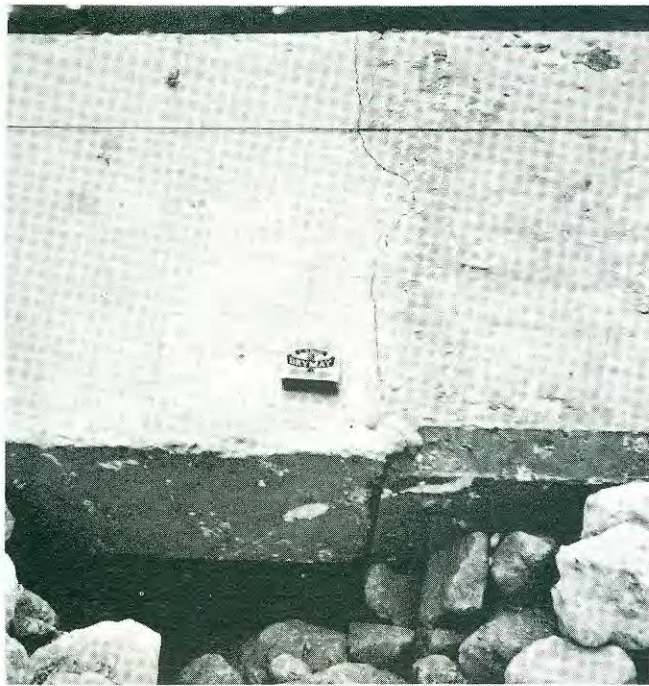
Fig. 5  
Typical construction joint crack

The reinforced concrete capping beam had five significant cracks extending at least half the depth of both vertical faces and across the top, a typical one being shown in figure 5. The cracks were due to one, or a combination, of the following reasons - lack of preparation of the vertical surface of the previous pour, poor consolidation of the subsequent pour, shrinkage and the badly chosen position for a construction joint which coincided with a tie rod anchorage.

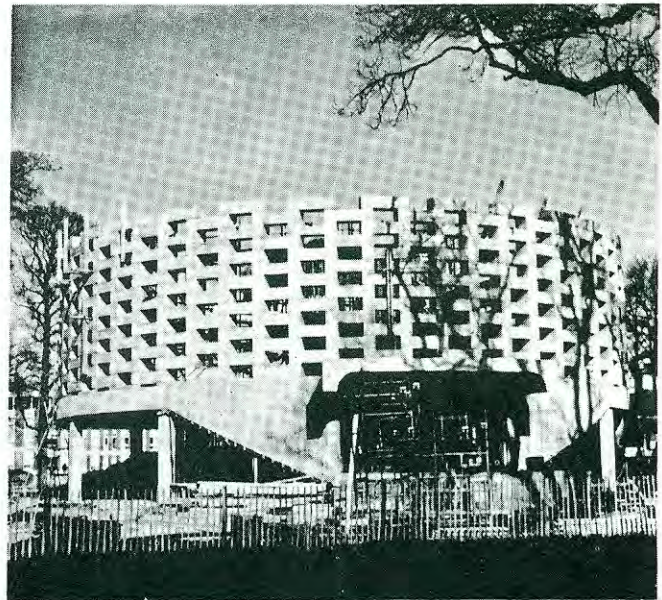
Meeting House without the lid on  
(photo: E. Mark)

The honeycomb wall acts as a brittle circular cylinder restrained at the top and bottom by the circular edge beams to the shell and the suspended slab. The final stability of the wall is dependent on the compression induced in it by the dead weight of the roof. There is a factor of at least two against cracks forming on the inside face of the wall between the blocks when the lower ring beam to the shell deforms outwards. The critical section of the wall is approximately one third of the way down from the top.

The reinforced concrete suspended slab is 1 ft. 3 in. thick and 80 ft. in diameter supported by a central column and an edge beam around the periphery. Two 9 in. reinforced concrete walls provide additional support to the slab where the stair wells occur. Columns and walls extend 10 ft. below ground level to mass concrete foundations bearing on chalk.

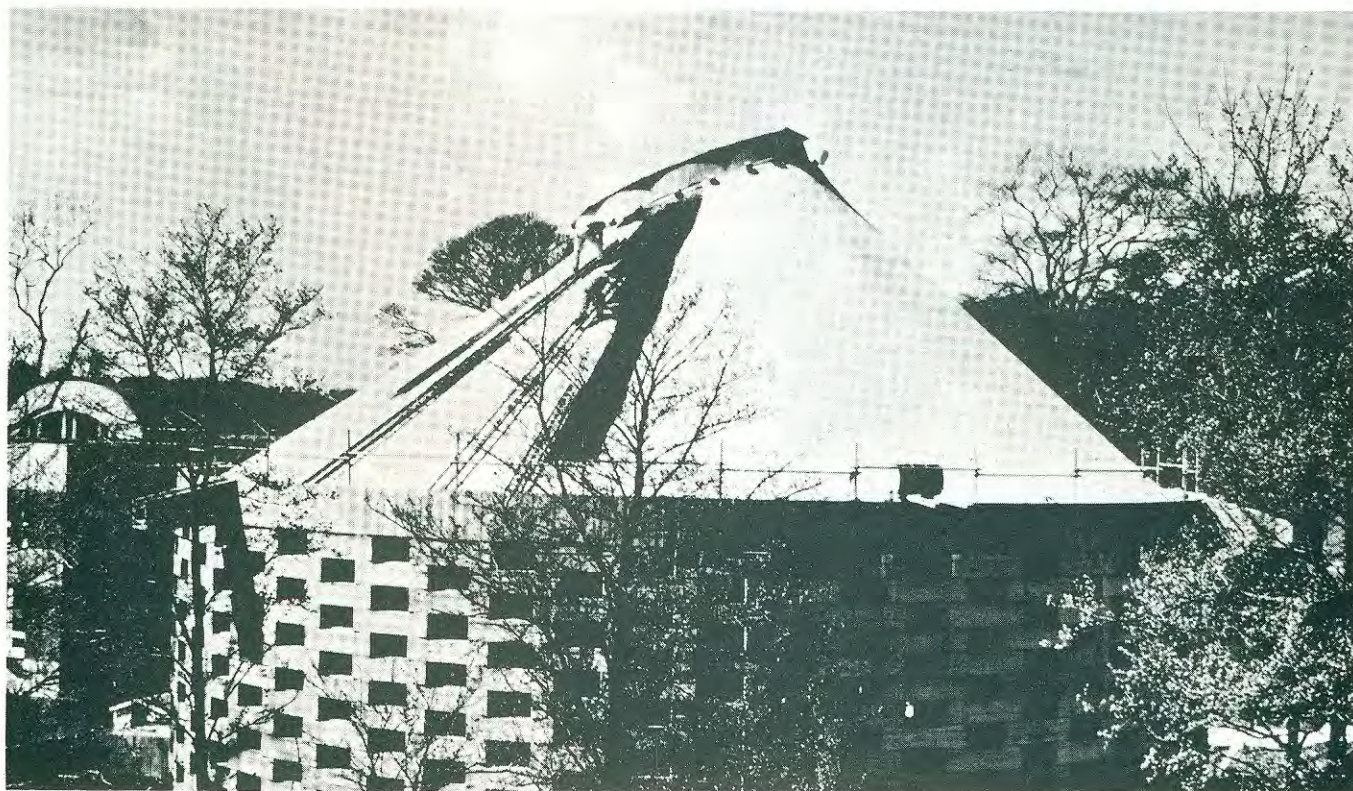
View of completed concrete shell  
(photo: E. Mark)

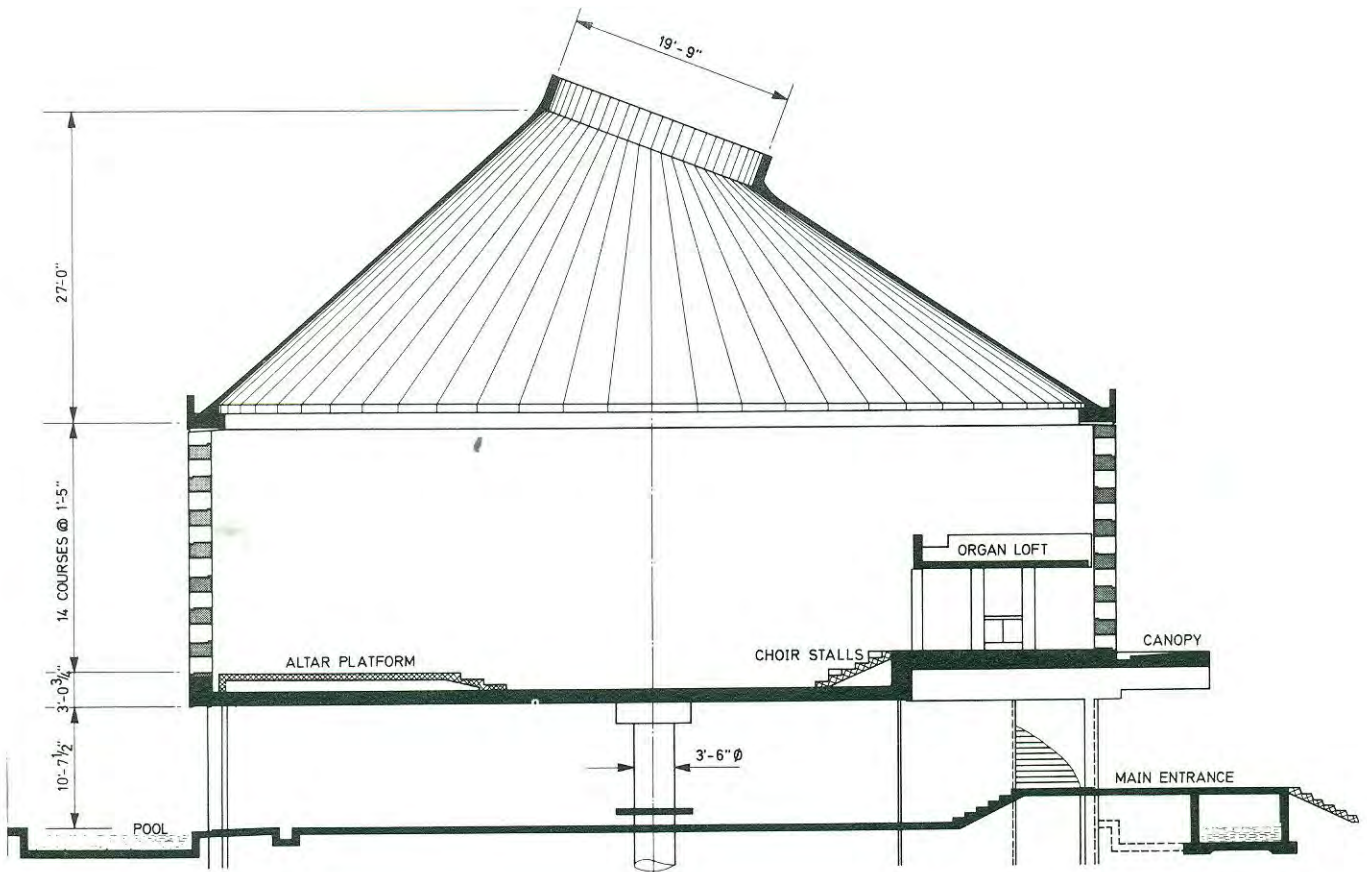
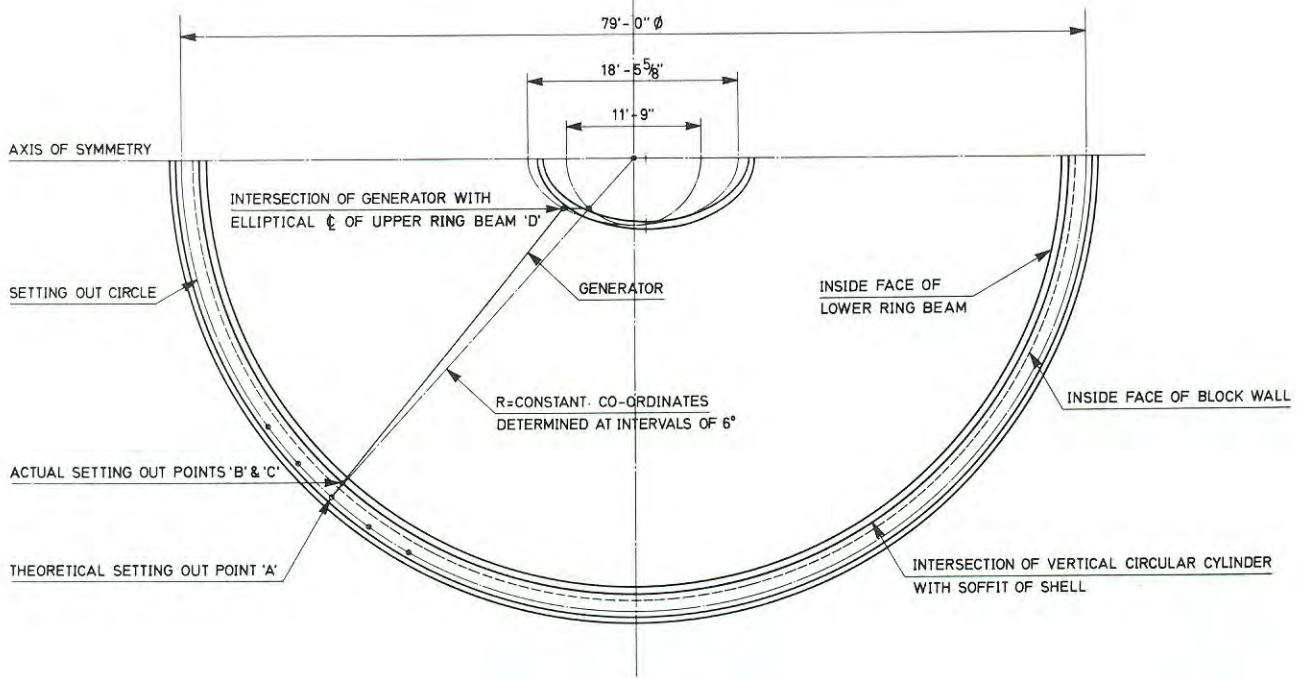
Half plan of roof

The shell roof is conical in form, transforming from a horizontal circular base at the bottom to an inclined elliptical opening at the top. The lower ring beam sits on 60 rubber pads with a low shear stiffness. This permits the ring beam to deform horizontally relative to the wall without throwing too great a lateral load onto the wall. Steel dowels cast into the blocks and adjacent to the bearings, project into sleeves formed in the ring beam. These dowels were grouted in three months after the shell was unpropped. This provision has been made because there is no information available regarding the durability of the rubber bearings over a long period of time. Grouting the dowels in after a period of three months ensures that the major part of the deformations due to dead load occur before the beam has a positive shear connection with the wall. The deformations due to live load are small and those due to temperature variations are also small and limited because the shell itself is well insulated.
