THE ARUP JOURNAL

The Island Site, Addiscombe Road, Croydon, Surrey, by T. Henry and P. Ryalls	2
The design and construction of Sheffield University Concourse, by K. Ranawake, R. Gordon and K. Tune	11
Preston Bus Station and Car Park, by R. Stephenson	19
Rooms for students, by T. Sturgis	27

The Island Site, Addiscombe Road, Croydon, Surrey

Tom Henry and
Peter Ryalls

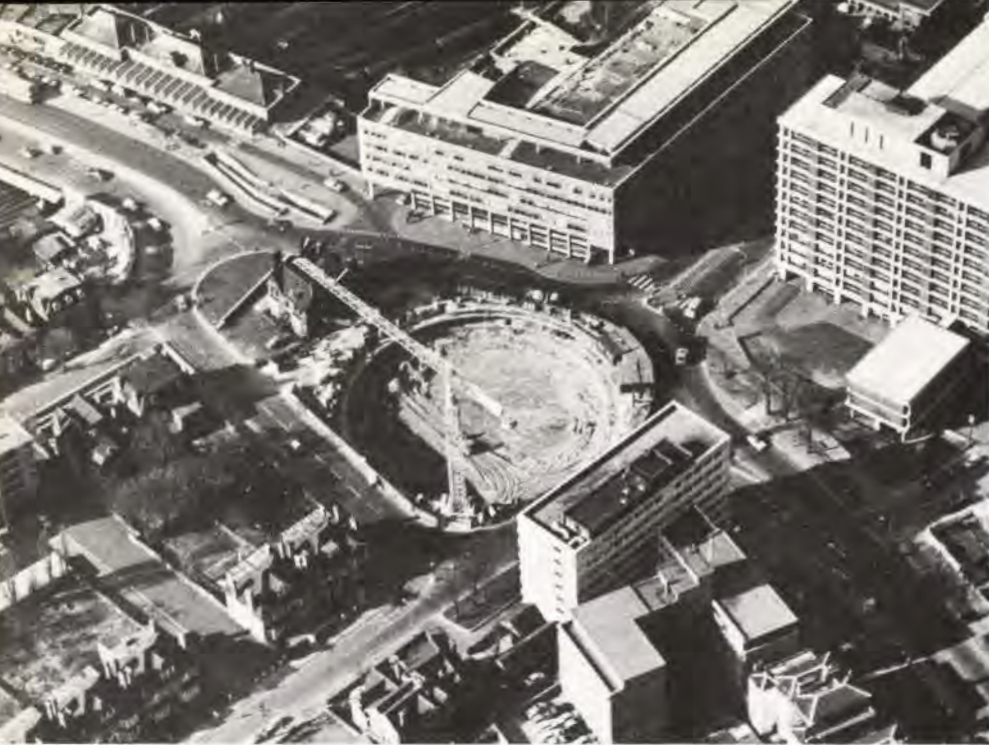
Fig. 1
Aerial view of the site
during excavations.
(Photo : Handford Photography)

The development is situated on a triangular-shaped traffic island, (Fig. 1) bounded on all three sides by a one-way, high density traffic system. There is a road junction at each corner of the triangle. It is connected by three pedestrian subways to both the railway station and adjacent office developments, thus eliminating the need for pedestrians to cross the roads at ground level.

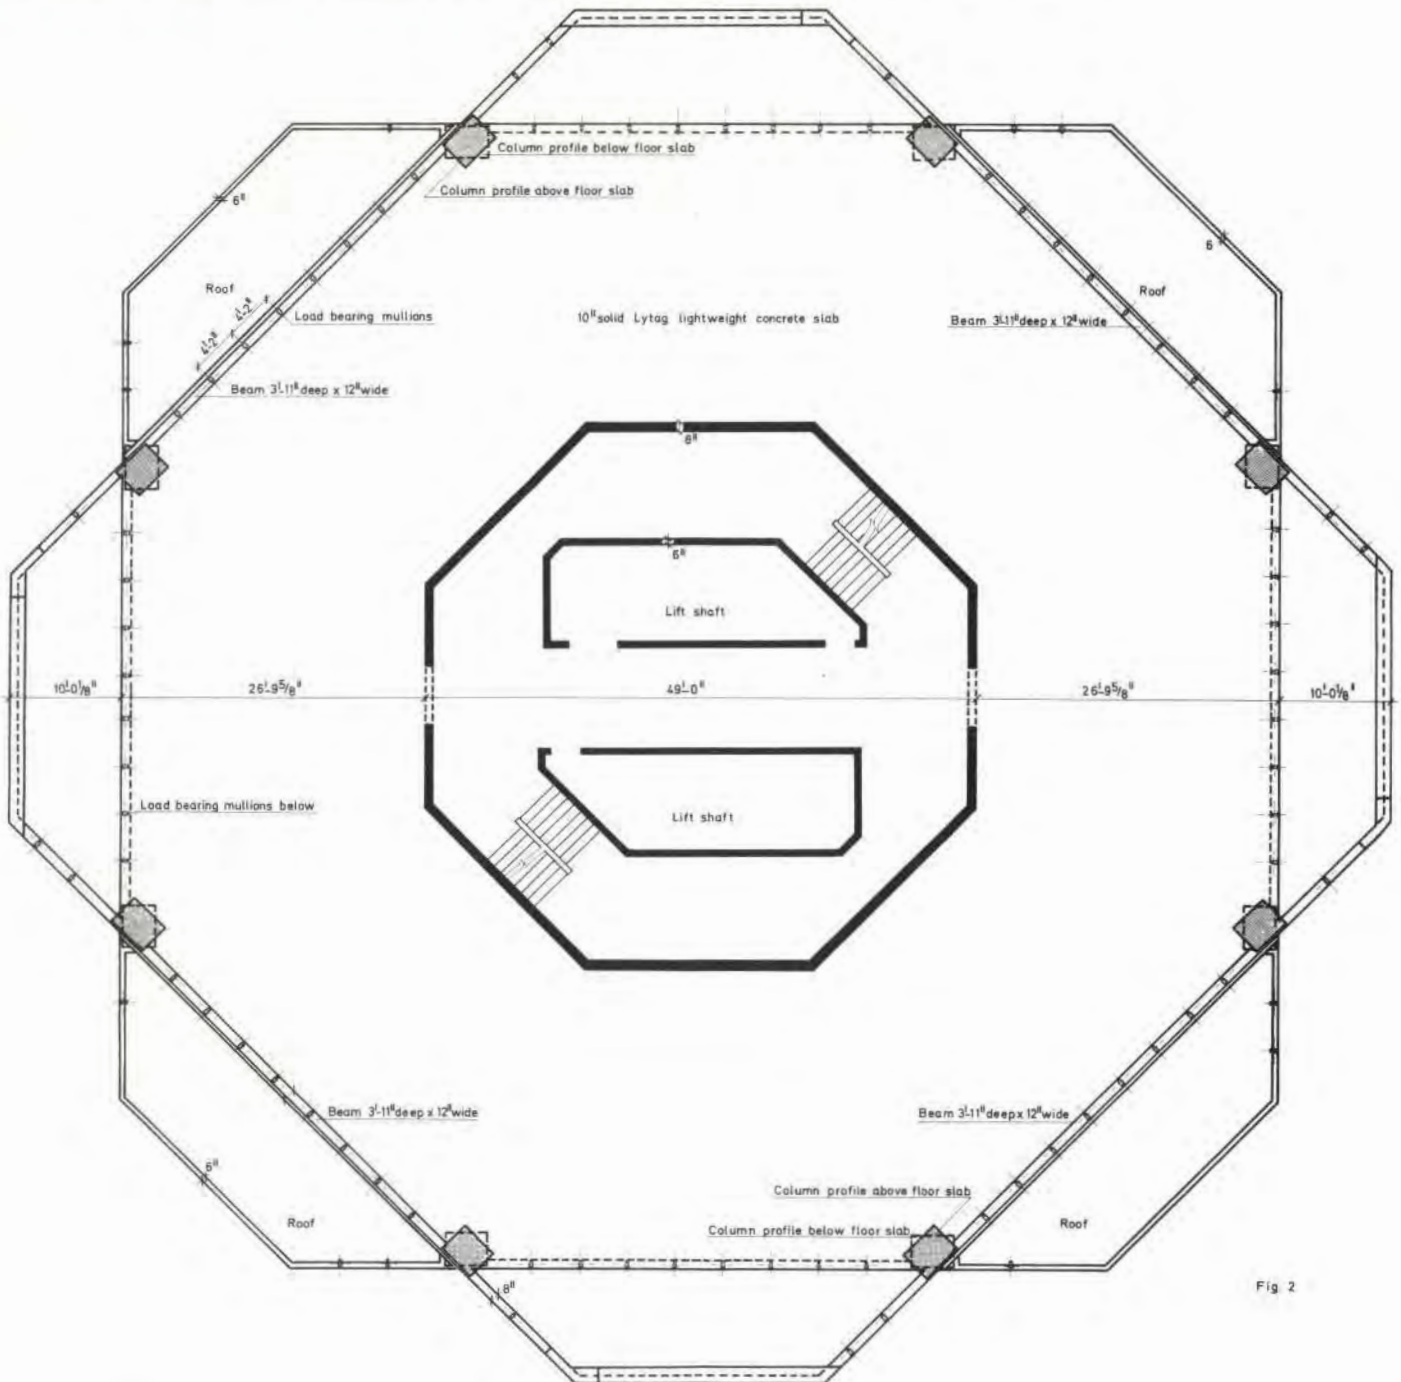
Fig 2

Fig. 2 below
Typical floor plan.

Above ground, the building is unusual in plan (Fig. 2), the perimeter being a twenty-four sided figure formed by superimposing two squares above each other, one square rotated at 45° with respect to the other, and then cutting the corners off each square to form two unequal sided octagons superimposed on each other. (In the initial schemes the corners were not cut off.)

There are 20 typical floors (Fig. 2) and each is a 10 in. (250 mm) solid flat slab disc of lightweight *Lytag* concrete supported at the centre by the service core walls, and at the outer edge by four perimeter beams formed of dense concrete and four rows of load bearing mullions at 4 ft. 2 in. (1.27 m) centre to centre.

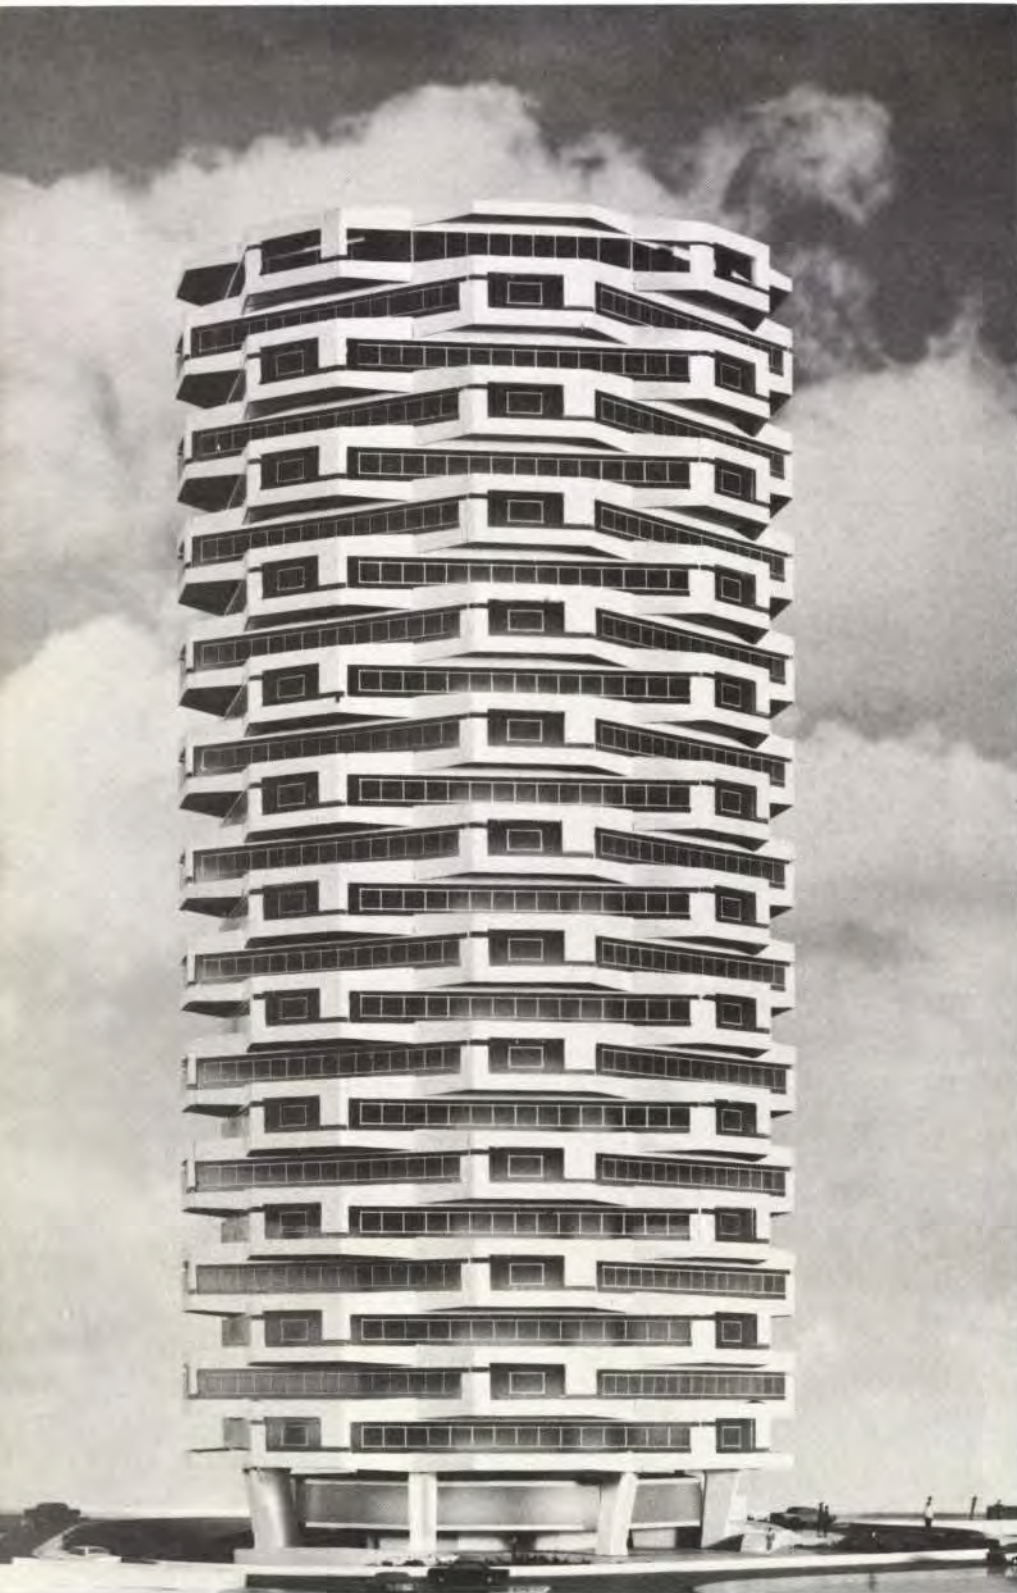
Fig. 3
Architectural model of the development.
(Photo: Fox Photos Ltd.)
Reproduced by permission of R. Seifert and Partners.

The effect of rotating the floors and providing balconies is to produce a building which externally gives the impression of being circular with bold projecting facets, rather like a very knobbly pineapple (Fig. 3), but which has the great advantage of having office floor plans which are almost square. The balconies provide the further advantage of shielding the windows by an 11 ft. (3.4 m) overhang and also serve to collect rainwater at each level and thus eliminate the problem of progressively larger quantities of rainwater passing down the face of the building to be collected somehow before ground level is reached. This problem is not always dealt with adequately at the design stage.

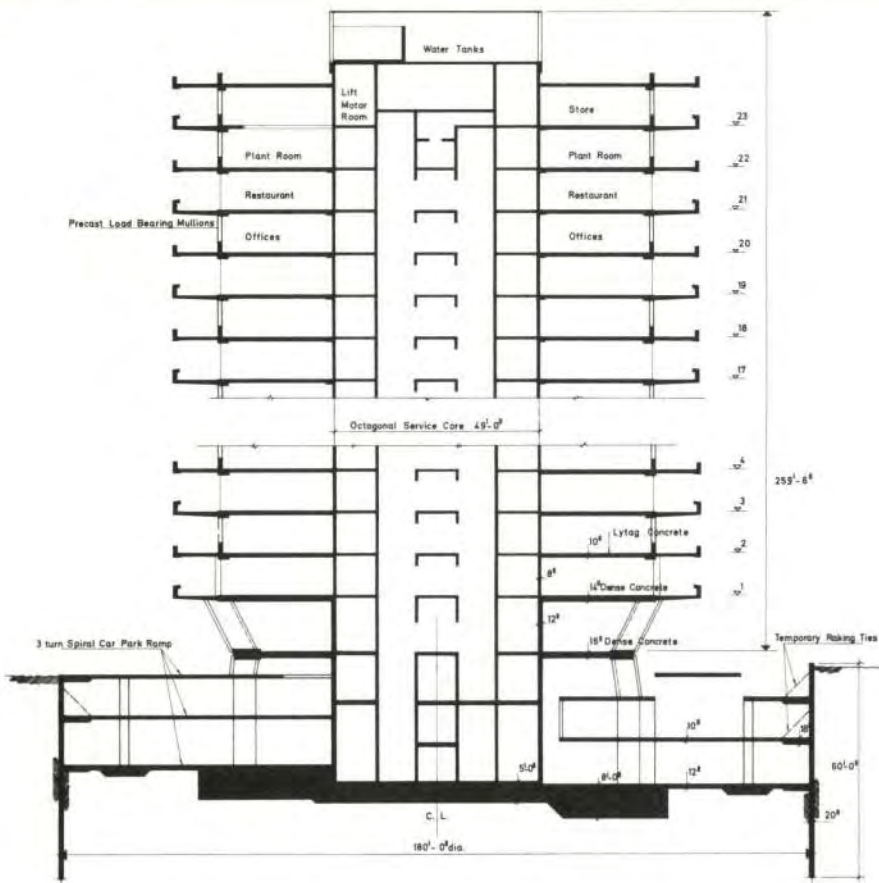
Fig. 4 left
Vertical section through the building.

Between ground and first floors the architects have boldly expressed the vertical structure, a characteristic for which they are well known (Fig. 4). The glazing line is withdrawn inside the line of eight perimeter columns, the plan shape varies, and, in radial elevation, the columns slope slightly towards the centre of the building between lower ground floor and ground floor and then sharply away from the vertical between ground and first floors.

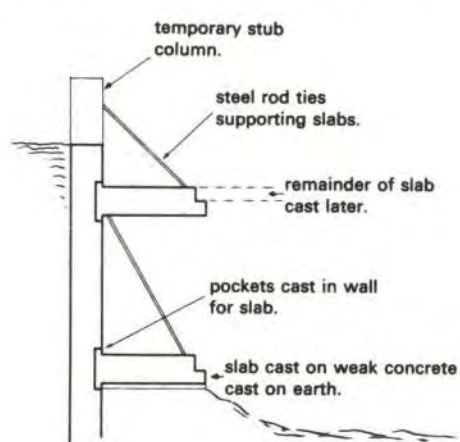
Fig. 6
Excavation of car park showing stiffening ring (cast on ground) supported by raking ties. Excavation was entirely by mechanical equipment with complete elimination of any temporary propping. (Photo: E. J. Studios). Reproduced by courtesy of Taylor Woodrow Construction Ltd., who are the main contractors.

The stiffening ring was cast in situ using the unexcavated ground as propping for plywood sheets laid on the ground (Fig. 6). Concrete was then placed on the plywood and into rebates in the diaphragm wall. These were formed by attaching polystyrene blocks 2 ft. x 3 in. (610 mm x 75 mm) to the reinforcement cages of the diaphragm wall before they were lowered into position through the bentonite.

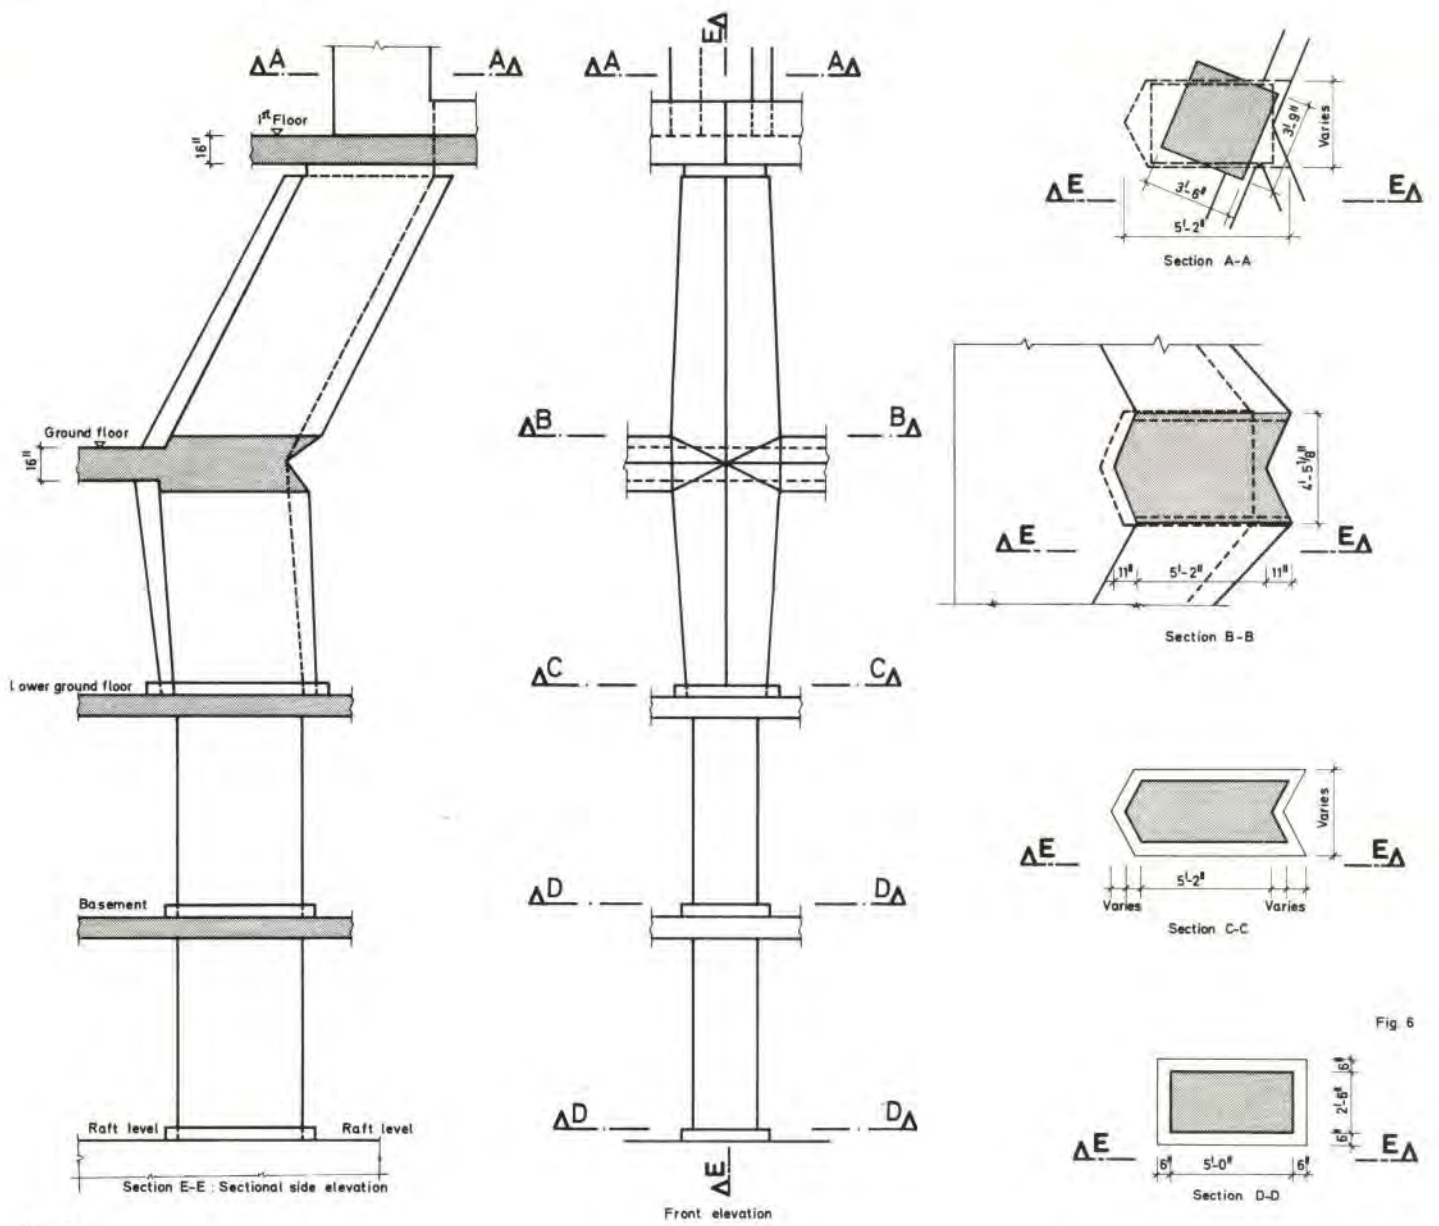
Fig. 7
Elevation and sections of the sloping columns between the raft and first floor.

From raft level upwards, through two floors, the columns are rectangular, vertical, and continuous in section. Between lower ground floor, ground floor and first floor they have a constantly changing chevron shaped section and no longer remain vertical, sloping in towards the centre 9 in. (230 mm) between lower ground and ground floor, and sloping outwards 6 ft. 9 in. (2.1 m) (23° away from the vertical) between ground and first floor (Fig. 7). Above this level they are vertical.

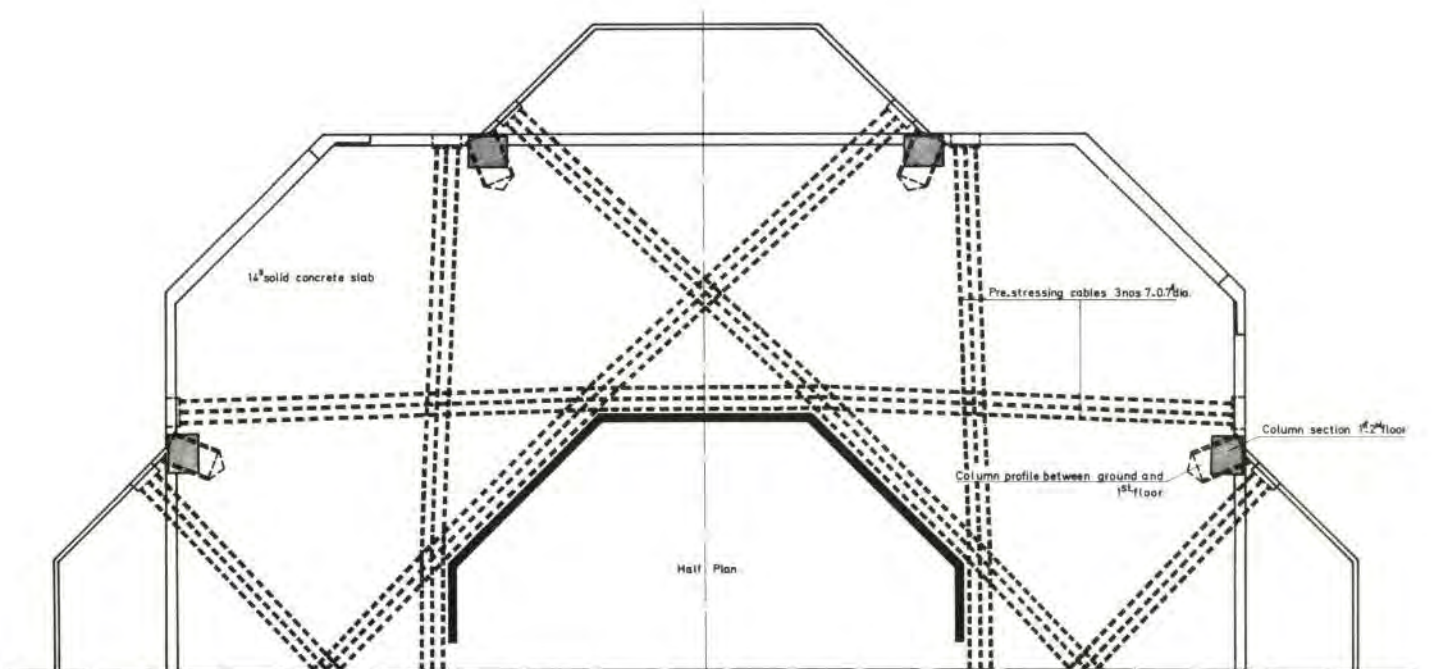
Fig. 8
First floor layout of prestressing cables.

At first floor level the sloping columns are tied into the building by a system of prestressing cables laid at mid depth of the 1ft. 2 in. (360 mm) thick dense concrete floor slab. Six cables restrain each column and exert a total radial tie force of approximately 1800 kips (Fig. 8).

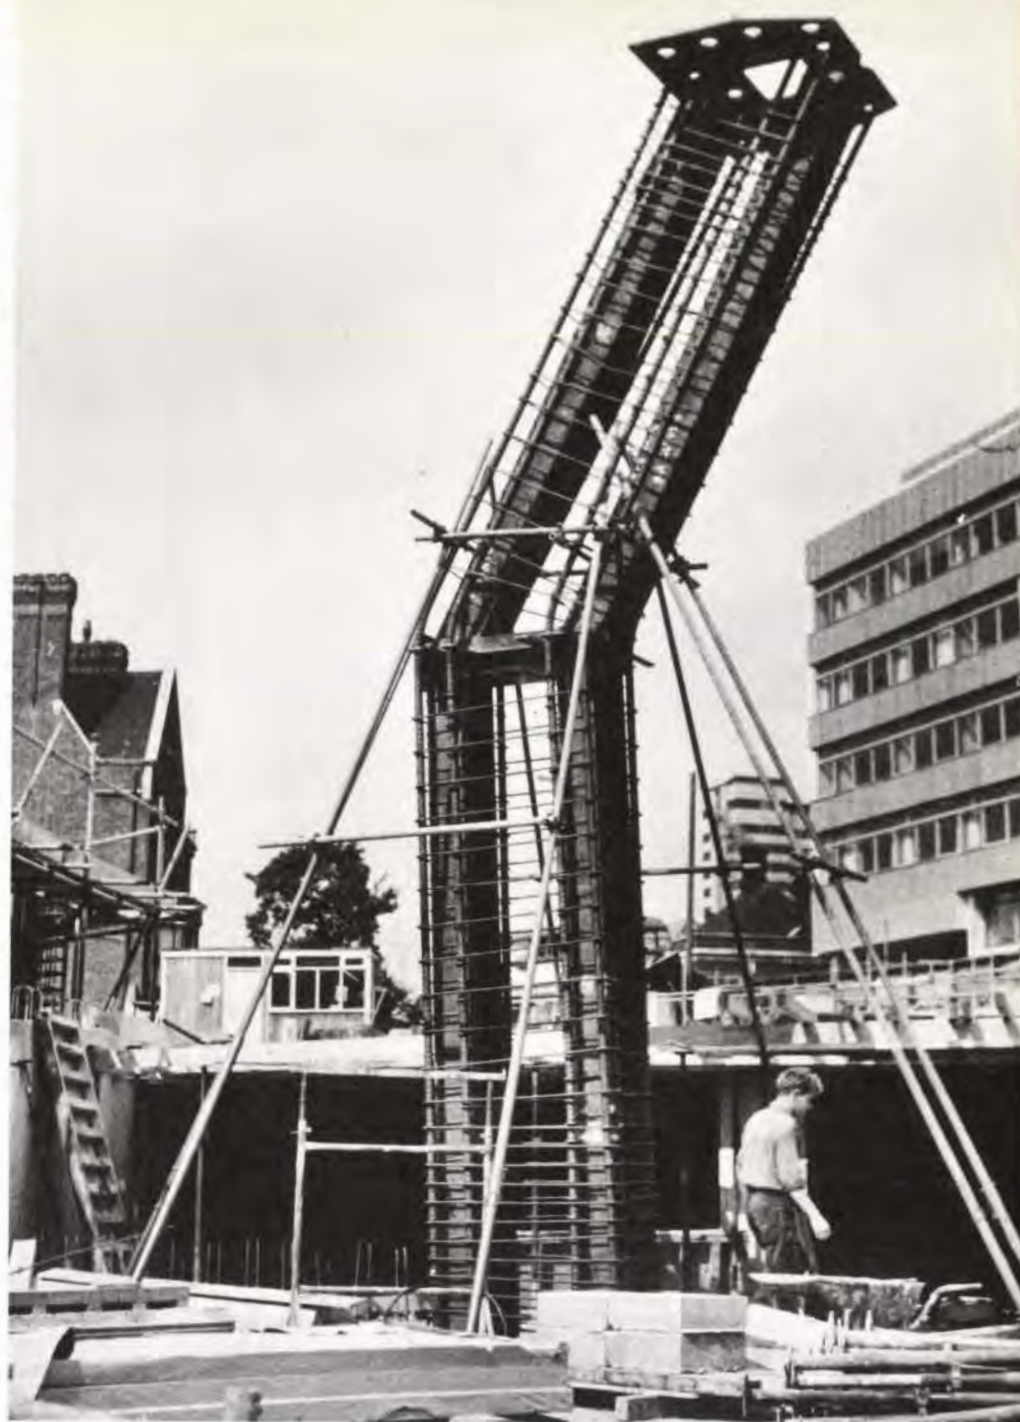
Fig. 9 Cranked column reinforcement formed by two 12 in. x 12 in. universal columns and eight 2½ in. diameter Hi-bond bars. (Photo: Peter Ryalls)

Thus the problem to be solved was that of providing reinforcement which could be accurately placed in all three planes. It was decided that reinforcement to the sloping parts of the column should be two 12 in. x 12 in. (305 mm x 305 mm) universal columns, cranked and welded at the change of slope and strapped together to form the main reinforcement (Fig. 9). The universal columns

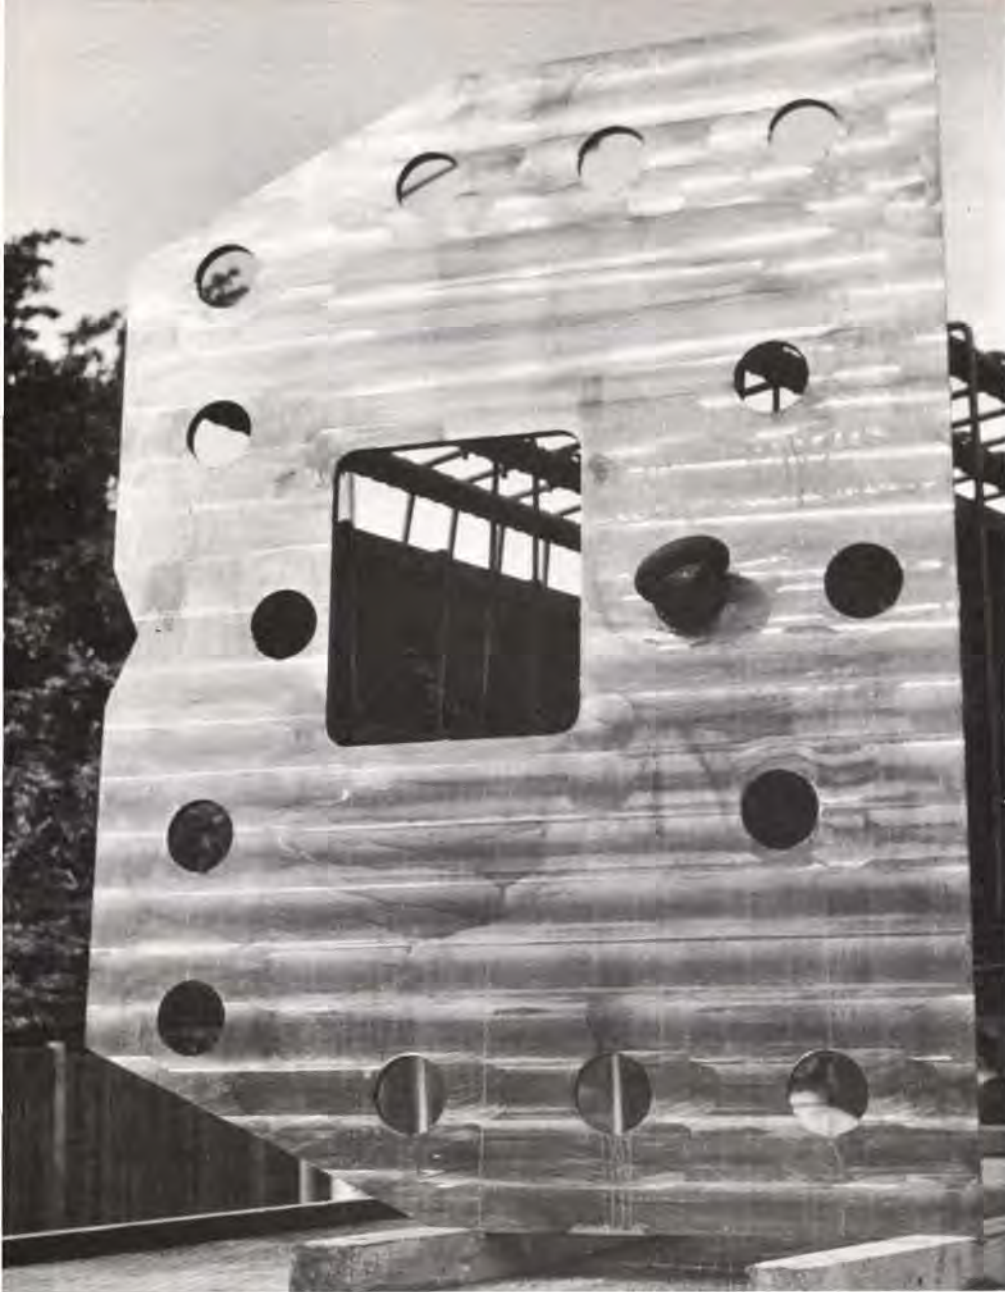
Fig. 10
Upper plate of fabricated column. (To this plate a loose plate containing 22 starter bars is welded at first floor.)
(Photo: Peter Ryalls)

were butt welded to machined base plates top and bottom (Fig. 10). Corner bar reinforcement was provided by four 2½ in. (57 mm) bars also butt welded to the base plates. Shear connector links were welded to the universal columns and conventional links were attached to the 2½ in. (57 mm) bars. Because of the welding and the thickness of the sections and the difficulty of normalizing a fabricated element 28 ft. x 4 ft. (8.5 m x 1.2 m), the universal columns were specified as ND (notch ductile) 2b steel and the 2½ in. (57 mm) bars were McCalls weldable Unisteel '60'. This part of the work was put out to tender to steel work fabricators.

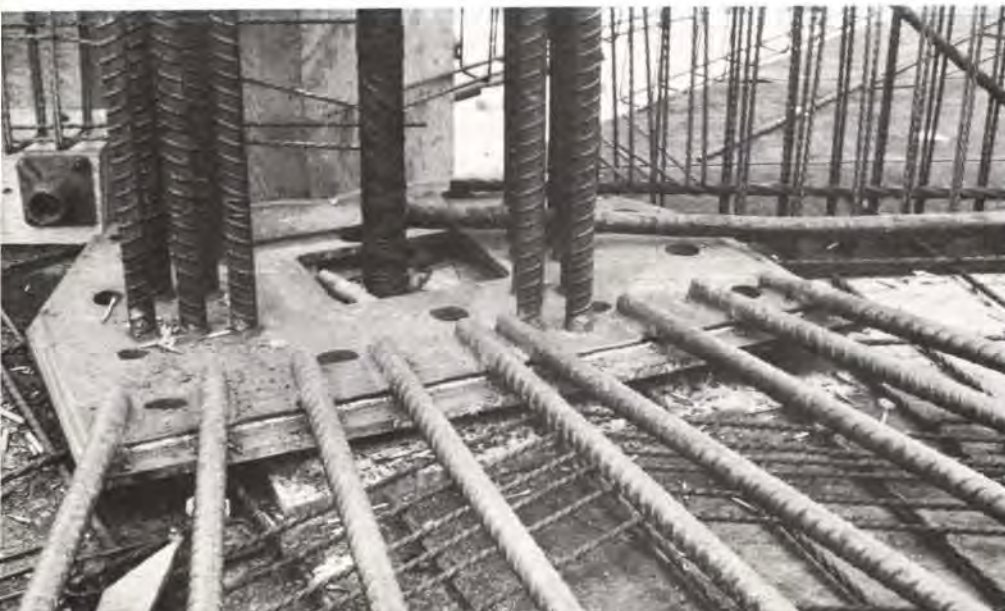
Fig. 11
Column at 1st floor level showing loose plate with 22 2 1/4 in. diameter vertical bond bars and nine horizontal 2 1/4 in. diameter *Hi-bond* bars welded to it, and loose plate welded to upper plate of the fabricated column. The 6 in. diameter rain water pipe is also shown passing vertically through a rectangular hole in centre of plates.
(Photo: Peter Ryalls)

At first floor level a loose plate was welded to the upper end of the steel column. To this loose plate, 22 2 1/4 in. (57 mm) bars were welded to act as starter bars for the column above the first floor (Figs. 11 and 12).

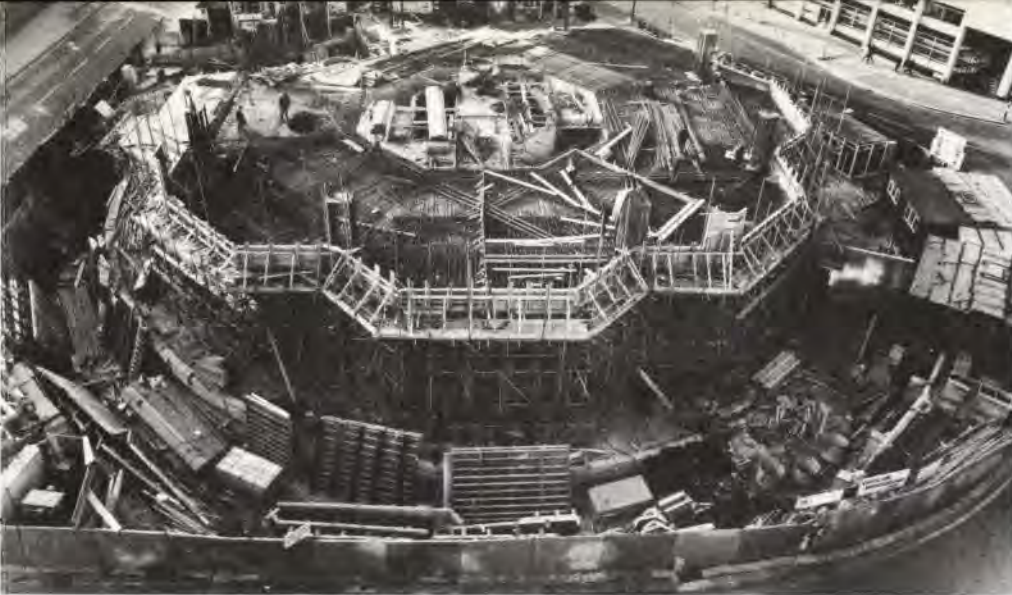
Fig. 12
1st floor level showing column reinforcement erected between 1st and 2nd floors and templates attached to the reinforcement. Some stressing cables are shown in position. (Photo: E. J. Studios). Reproduced by courtesy of Taylor Woodrow Construction Ltd.

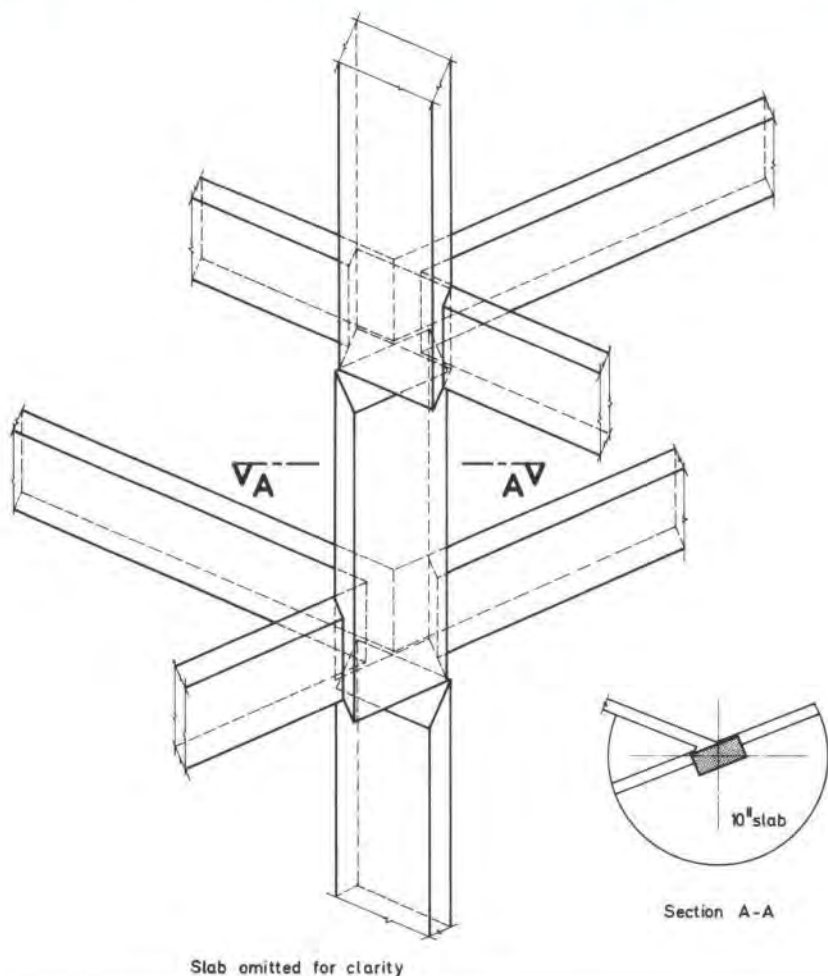
Fig. 13 left
Diagram showing the rotation of columns floor to floor.

Above 1st floor each column is vertical and rectangular in plan (Fig 13). At each floor the plan rotates through 45°, and the section reduces progressively up the building. On each successive floor a main edge beam frames into the column, on the opposite side of and 45° inclined to both that on the floor above and that on the floor below. In four of the eight columns a 6 in. (150 mm) rainwater pipe passes down the middle and collects water from balconies on alternate floors.

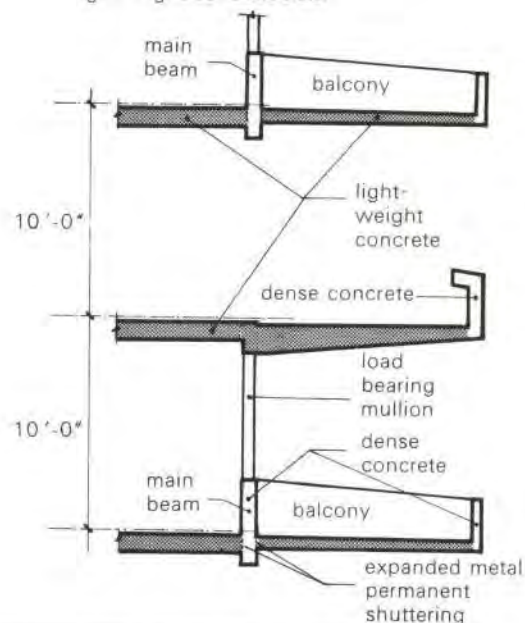
Fig. 14 below
Section through mainbeams showing the dense concrete beam projecting through the lightweight concrete slab.

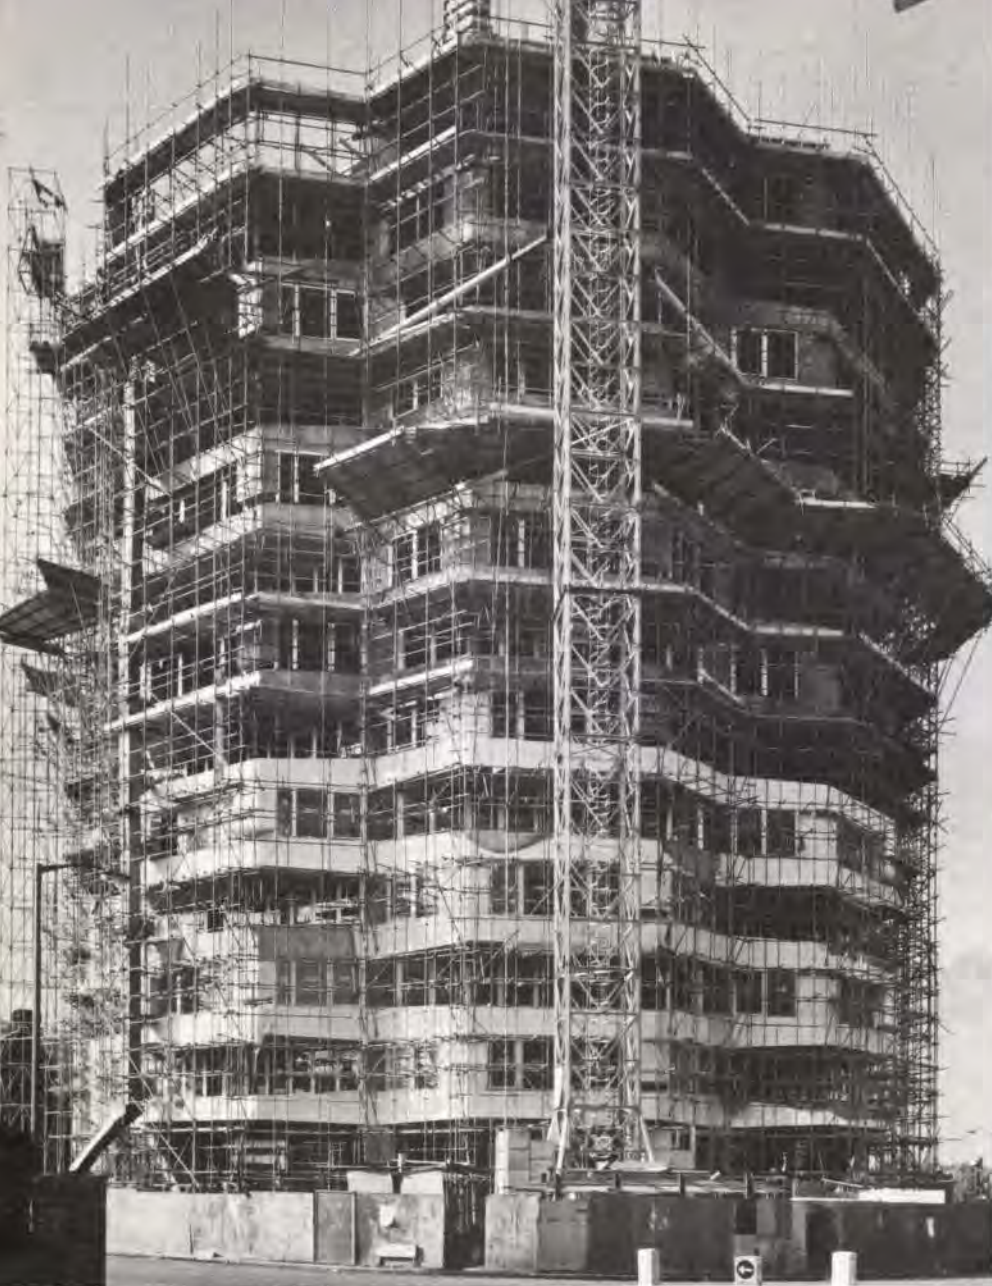
Fig. 15
View of building at end of September 1969,
with construction at 13th floor.
(Photo: E. J. Studios). Reproduced by courtesy of Taylor Woodrow Construction Ltd.

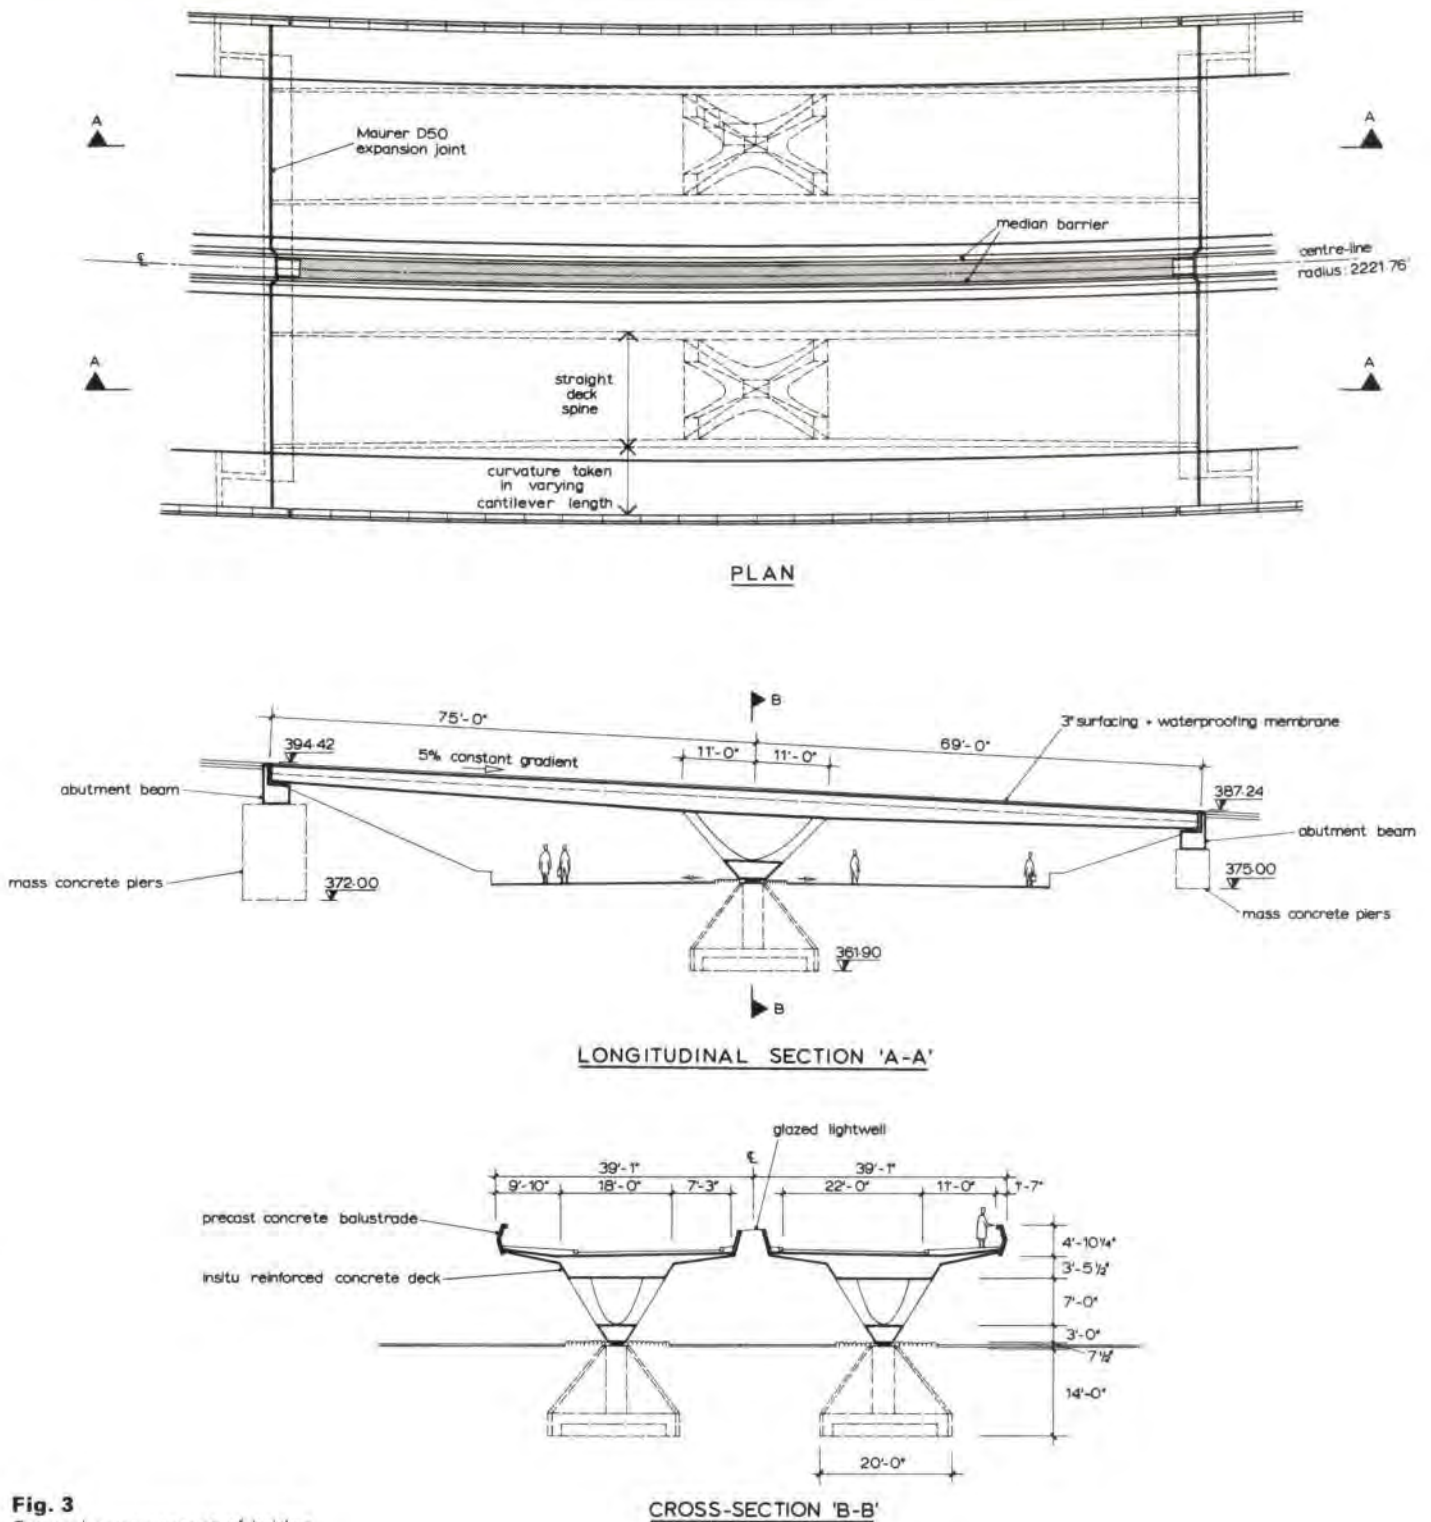
Fig. 3
General arrangement of bridge.

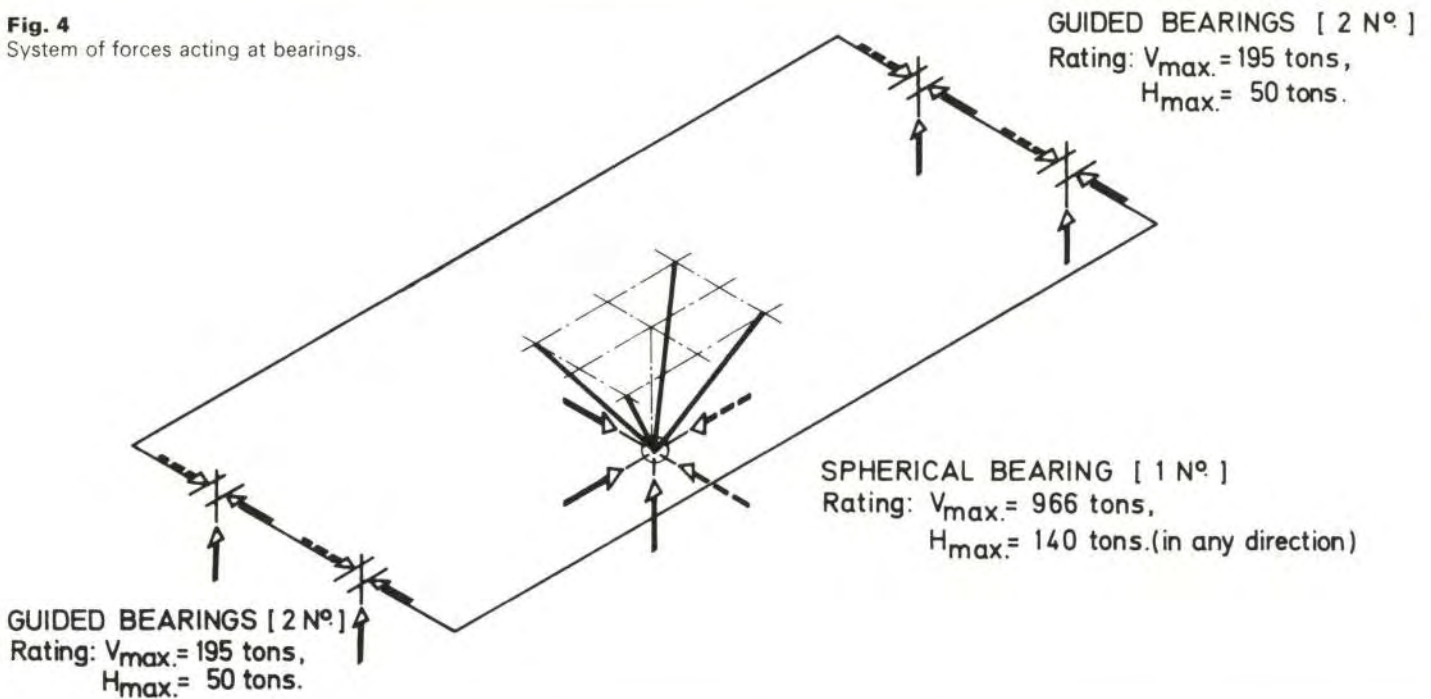
Fig. 4
System of forces acting at bearings.

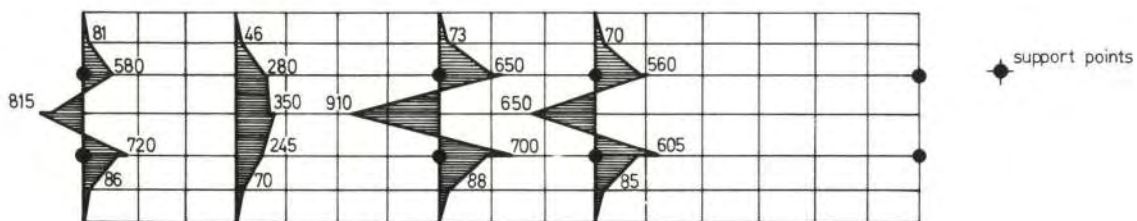
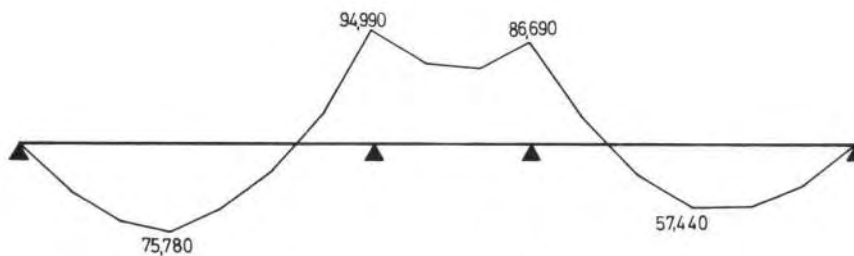
Transverse Bending Moments (kip.ins. / ft.width)
Loadcase :- dead load + HA load.

Longitudinal Bending Moments in Spine (kip.ins.)
Loadcase :- dead load + HA load.

Fig. 5
Typical distribution of bending moments.

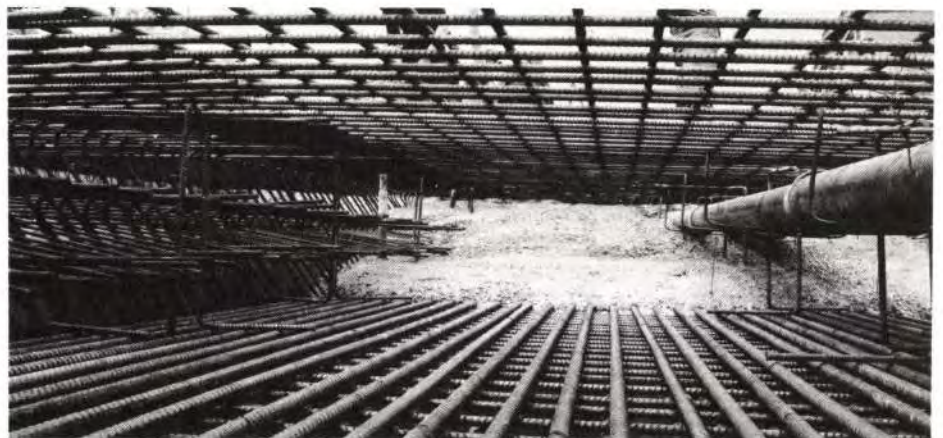
Fig. 6
Long wet edge of concrete.
(Photo: M. T. Walters and Associates Ltd.)

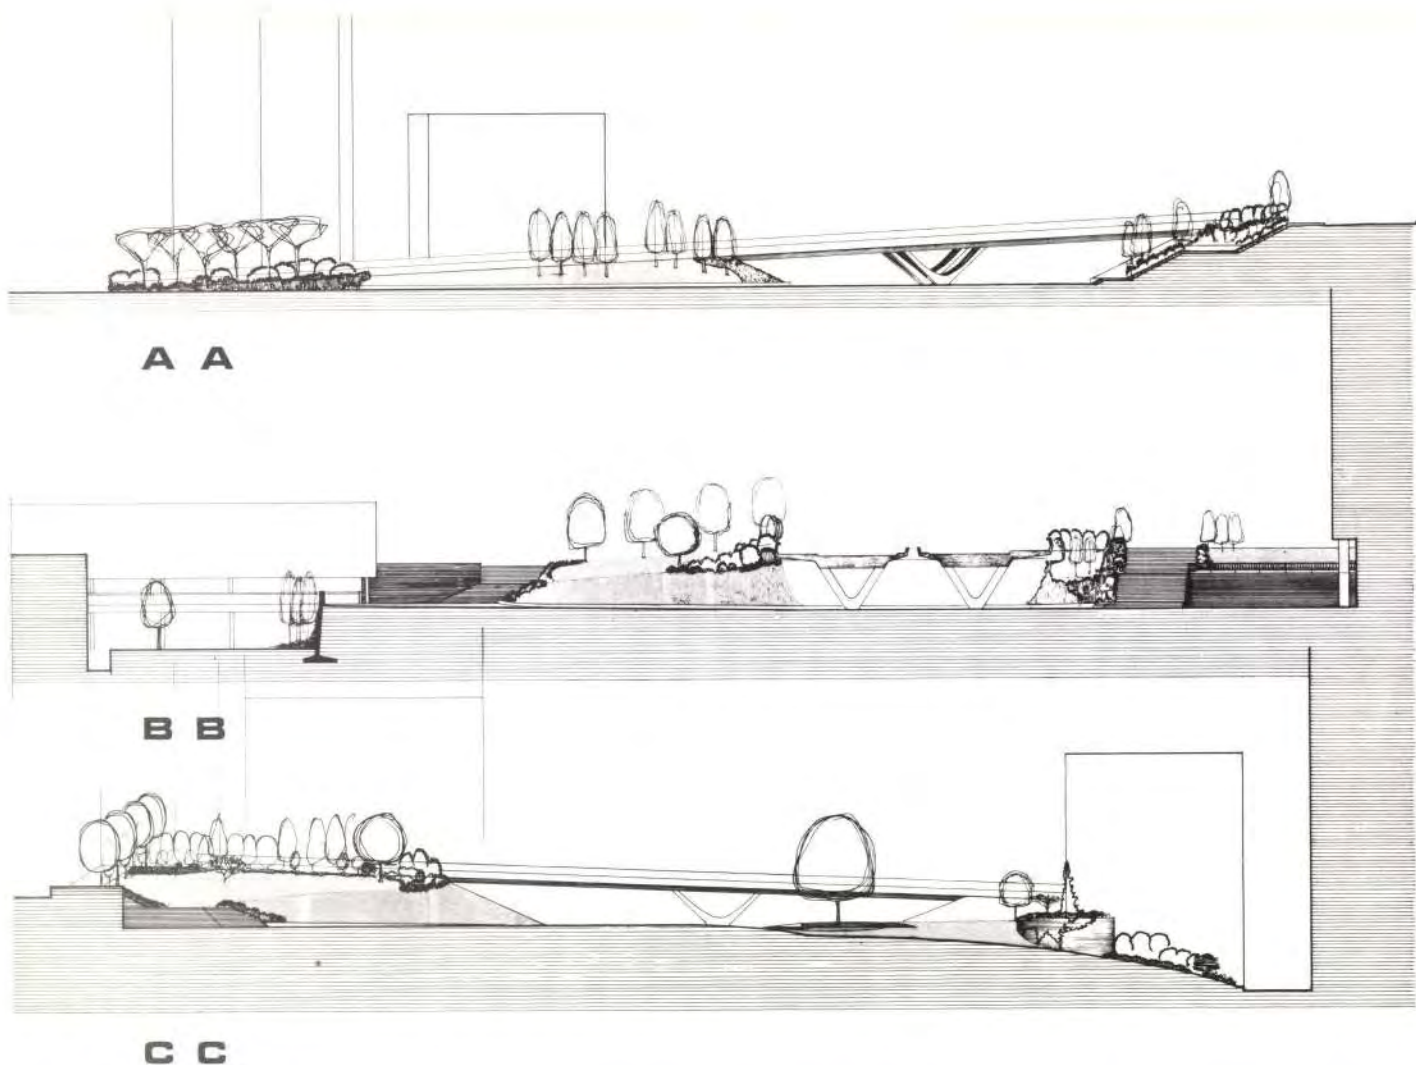
Fig. 7
Sections through concourse.

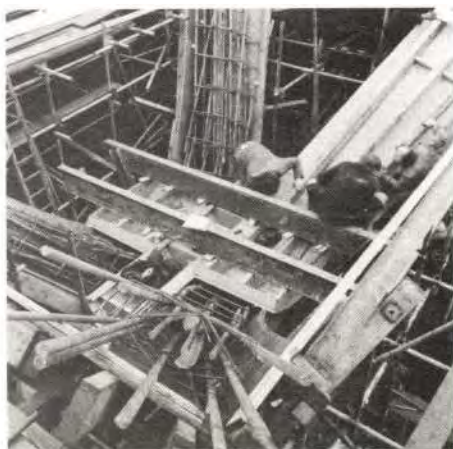
Fig. 8 above
Positioning of top shutter to central support.
(Photo: M. T. Walters and Associates Ltd.)

The central support was to be poured in a single operation and any movement during construction could create considerable difficulties. The outside shutters were therefore supported very firmly and the core top shutter anchored down to the foundations against the several tons of uplift that would occur. Ready-mixed concrete was used throughout the works and this created problems, as the only access was from the open half of the dual carriageway. The carriageway was therefore closed on a Sunday morning. The concrete was first poured through a central 9 in. (230 mm) diameter tube into the base until it rose up into the bottoms of the legs and then down each leg simultaneously. The result achieved, considering the difficulty of the operation, was quite good. Credit should go to the Ready-Mix supplier for his co-operation in producing a mix with the necessary

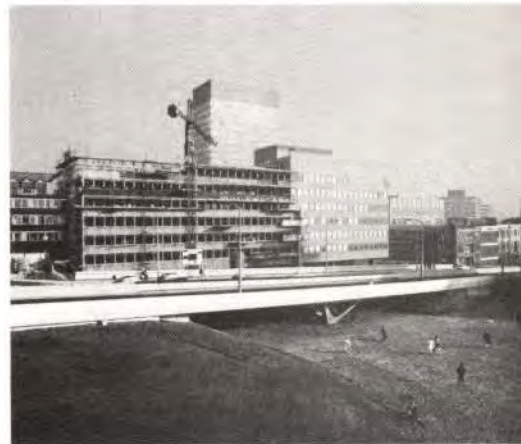
Fig. 12 above
North bridge before concreting.
(Photo: M. T. Walters
and Associates Ltd.)
