THE ARUP JOURNAL

The Island Site, Addiscombe Road, Croydon, Surrey, by T. Henry and P. Ryalls	2
The design and construction of Sheffield University Concourse, by K. Ranawake, R. Gordon and K. Tune	11
Preston Bus Station and Car Park, by R. Stephenson	19
Rooms for students, by T. Sturgis	27

The Island Site, Addiscombe Road, Croydon, Surrey

Tom Henry and
Peter Ryalls

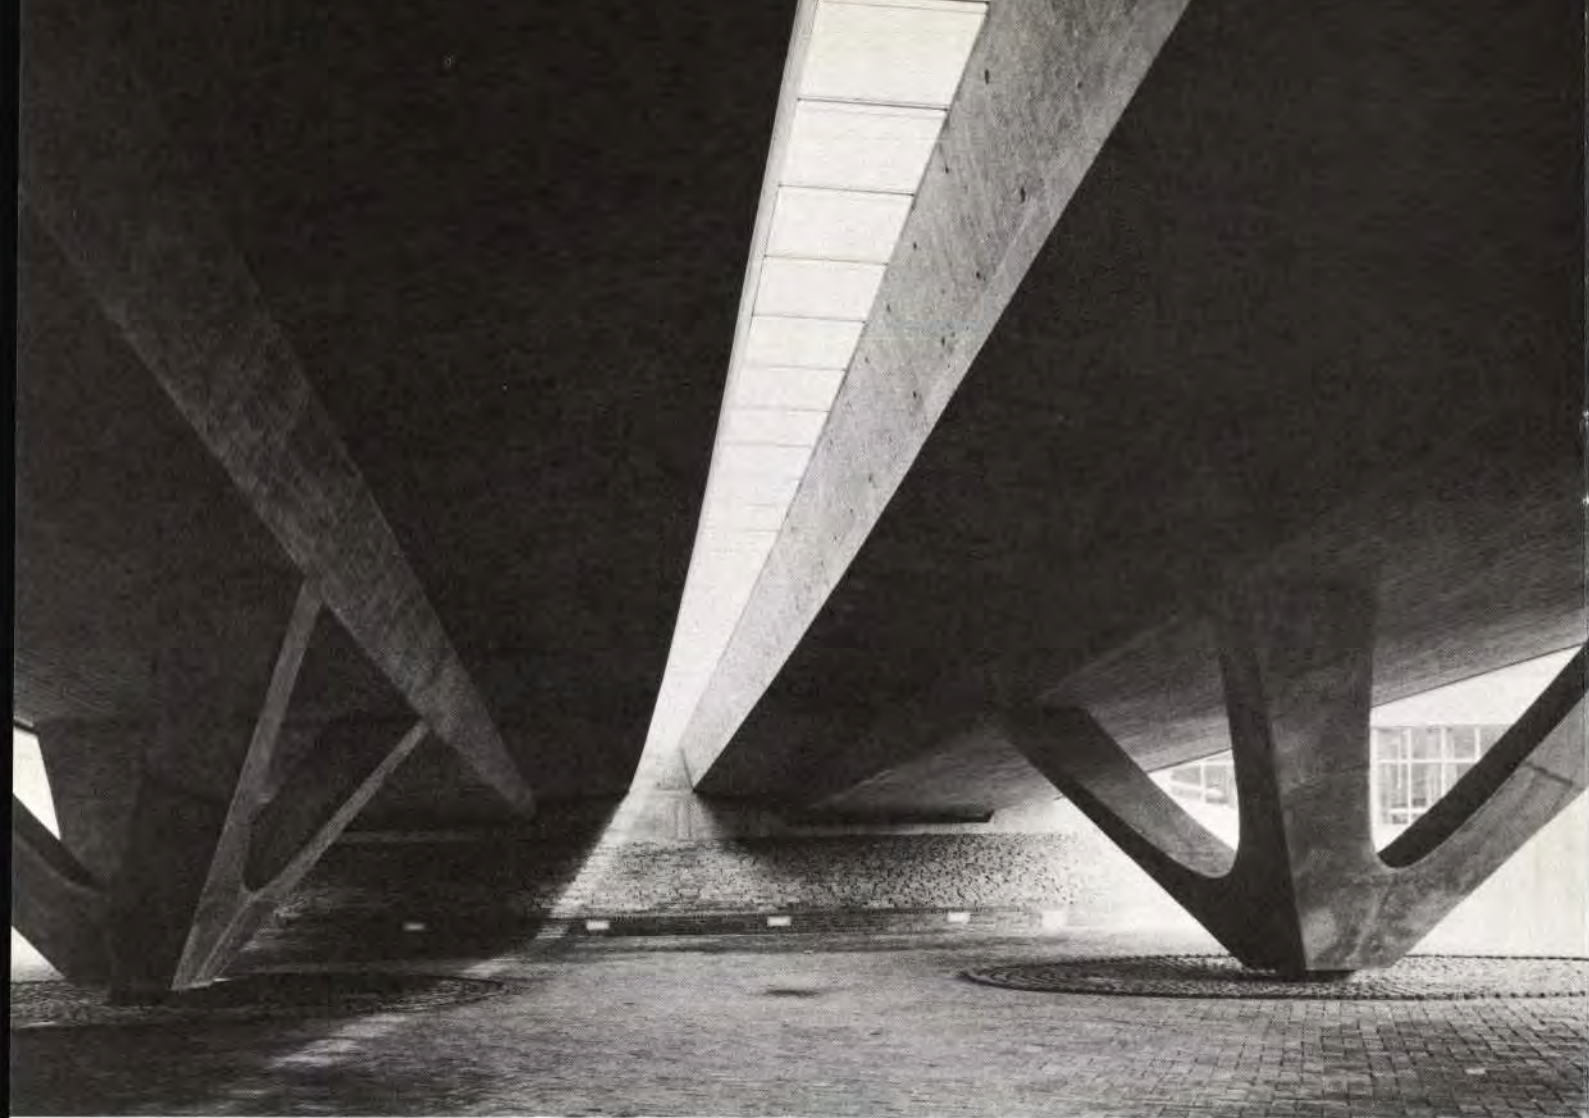
Fig. 13 above

'The connecting element should have a feeling of lightness and space.'
(Photo: Henk Snoek)

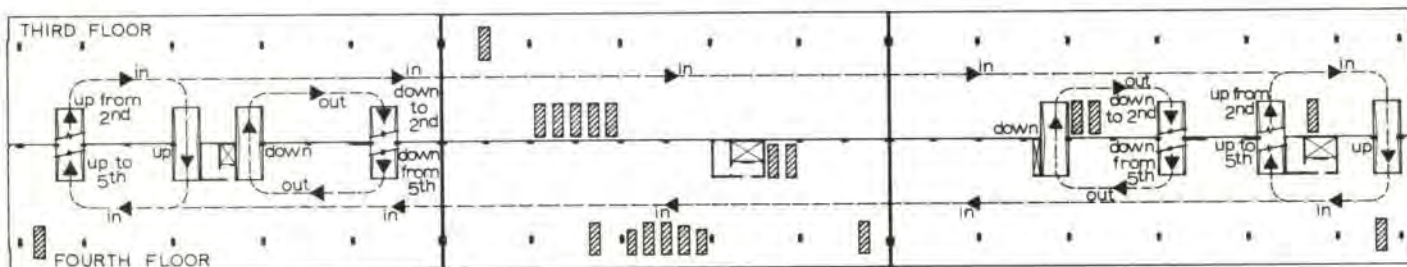
Fig. 2 Upper floor plan showing internal ramps.

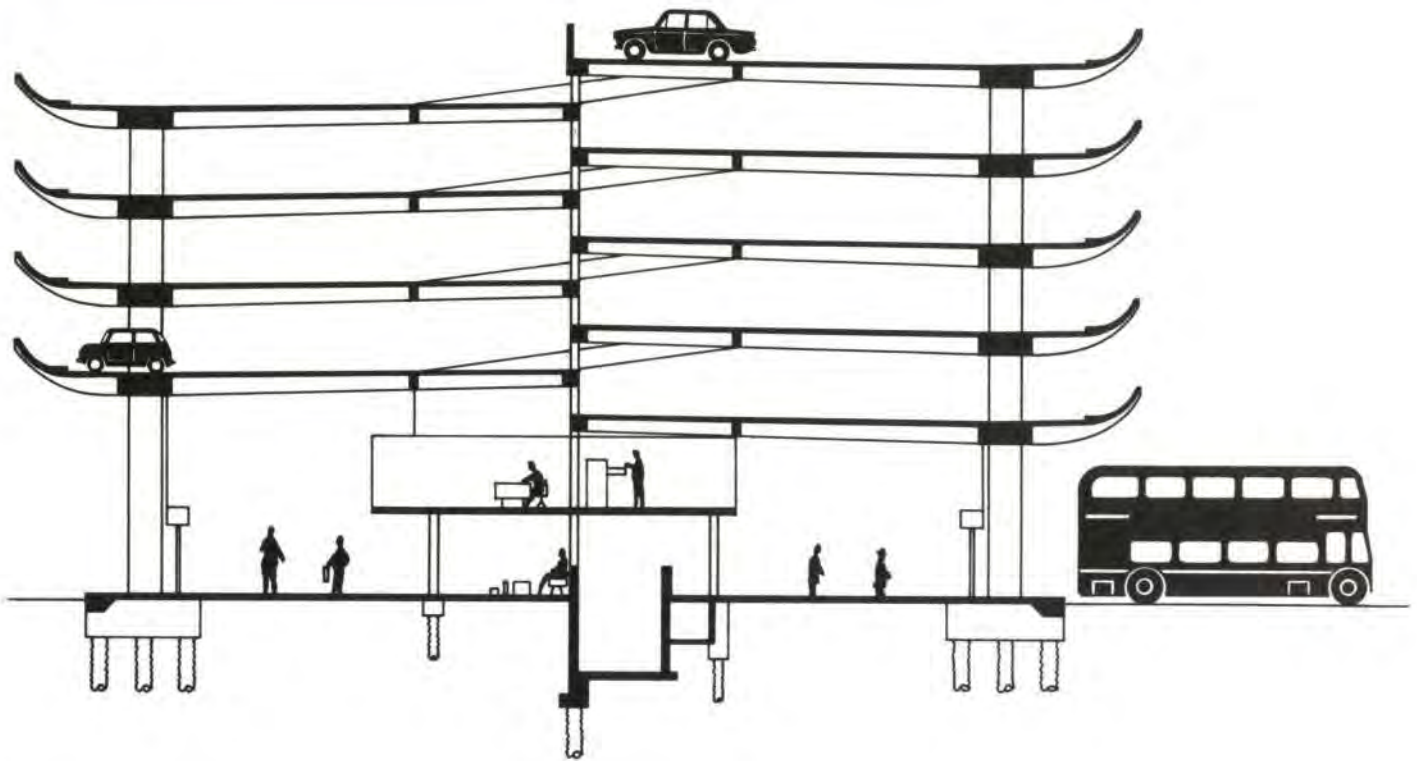
Fig. 3
Section through building.

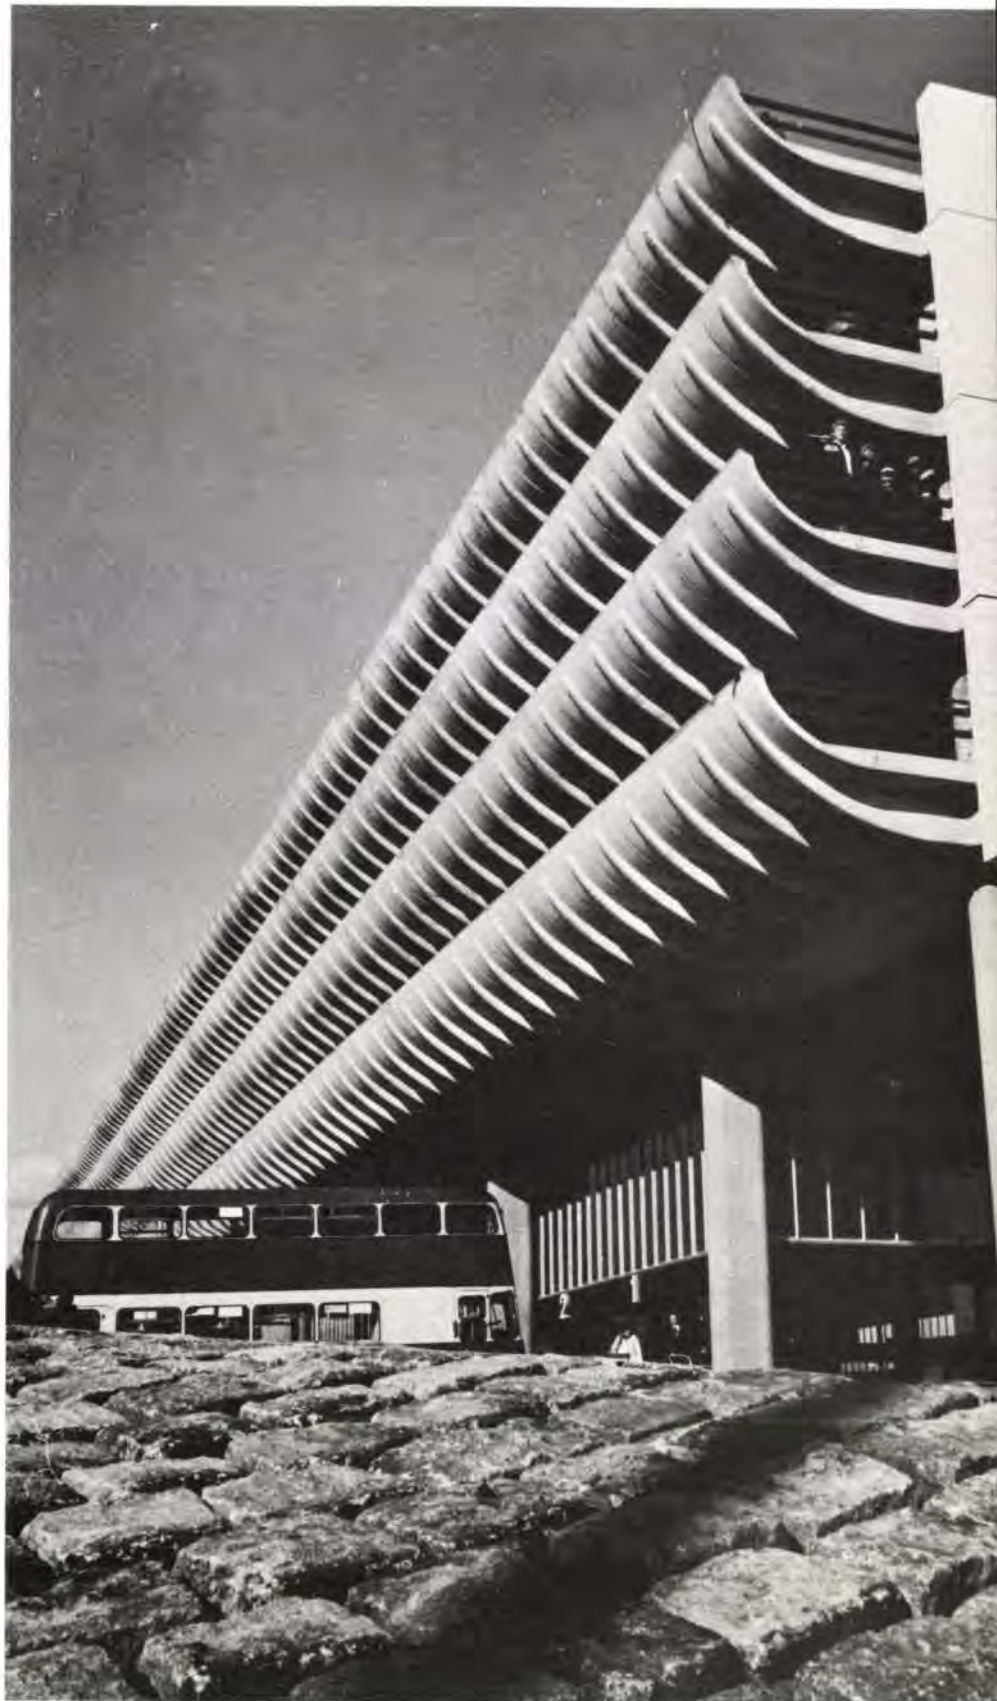
Fig. 4

The bus station looking from the south.
(Photo: Building Design Partnership)

We decided on a ribbed floor construction of precast units at an early stage in the scheming and, because the structure is expressed architecturally and so demands a consistently high standard of surface finish, we specified that the units should be cast in fibre glass moulds. The floor falls 6 in. (150 mm) to the external columns to provide drainage and, in addition, the rib depth increases from the building centre line (Fig. 3). This increase in depth was an architectural requirement to give a feeling of strength at the beam over the external columns and to provide a pronounced modelling to the soffit of the floor that cantilevers beyond the beam to form the floor balustrade. The ribs reduce in depth as they follow the cantilever's curve upward, finally petering out about 1 ft. 3 in. (380 mm) below the top of the curve and so leaving a plain un-modelled band that ties the edge in visually in a horizontal direction (Fig. 4).

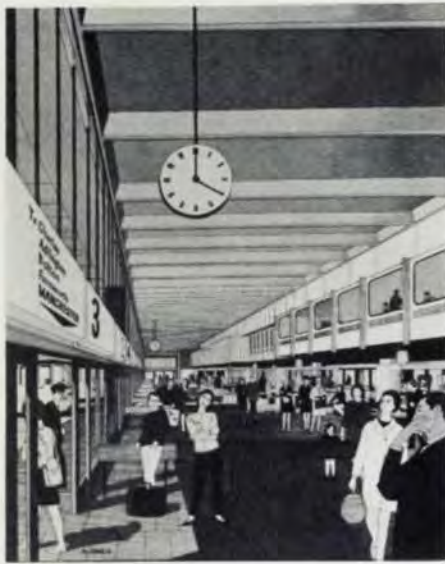
Fig. 5
Inside the concourse. Perspective drawn by Alan Mitchell.
(Photo: Building Design Partnership)

Access to the concourse is via one of three subways, each subway leading to either an existing or a planned shopping development; segregation of pedestrians and traffic at ground level being ensured by the use of large boulders in the landscaping and shoulder height precast concrete units forming barriers. The concourse is fully glazed on all sides, the glazing of the long sides being in the form of 13 ft. 4 in. (4 m) wide sliding doors at each bus stand (Fig. 5). The edge

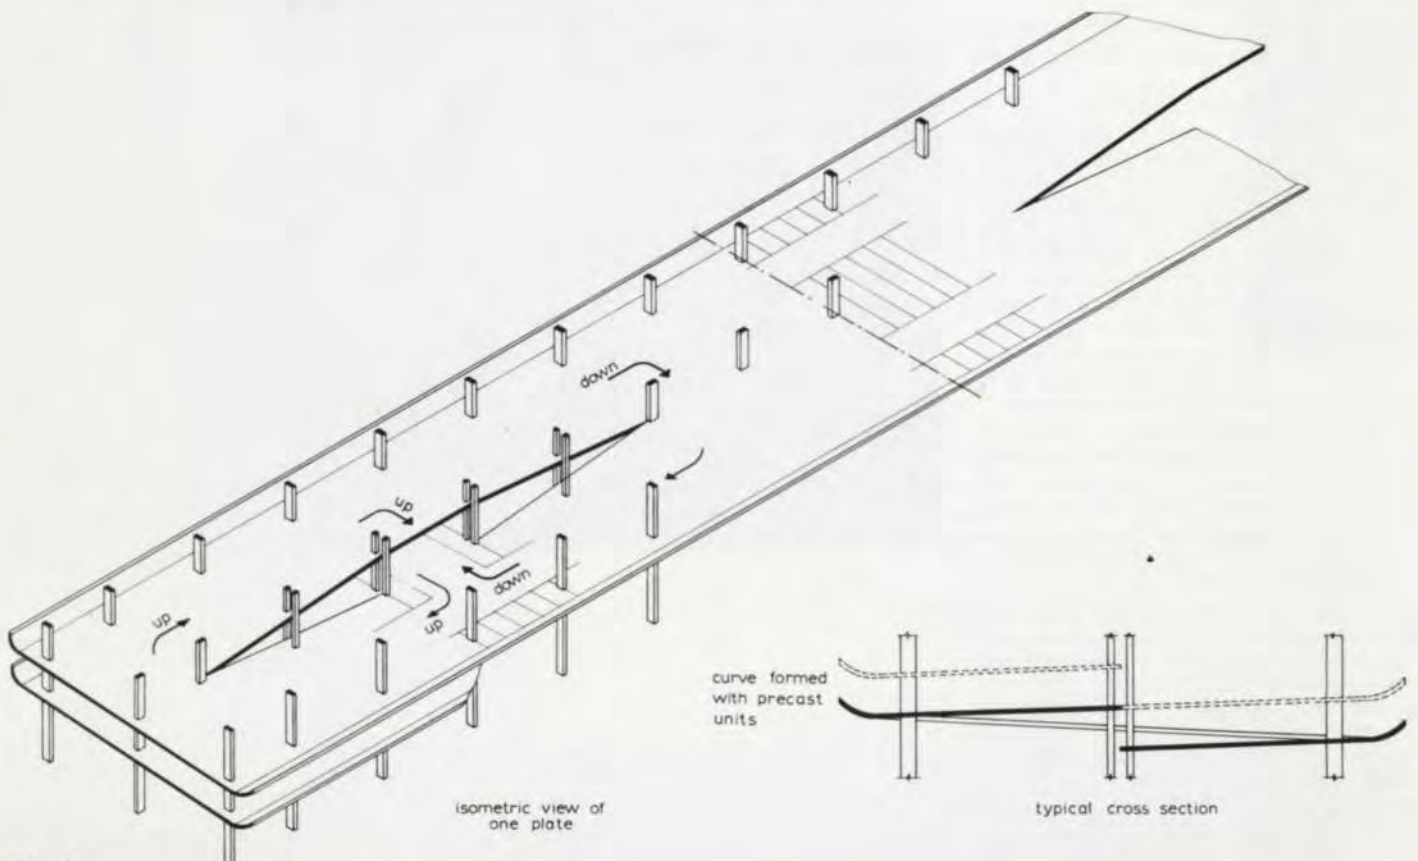
Fig. 6
British Lift Slab warped slab system.

Four alternative designs were put forward. Two were in steel and did not comply with the fire regulations then in force (2), nor were they aesthetically acceptable to the architect. A third was a precast concrete scheme that did not comply with the performance specification. The serious competition came from the fourth scheme. This was submitted by British Lift Slab Ltd. who put forward what they describe as the 'warped slab' system for the car parking floors (Fig. 6).

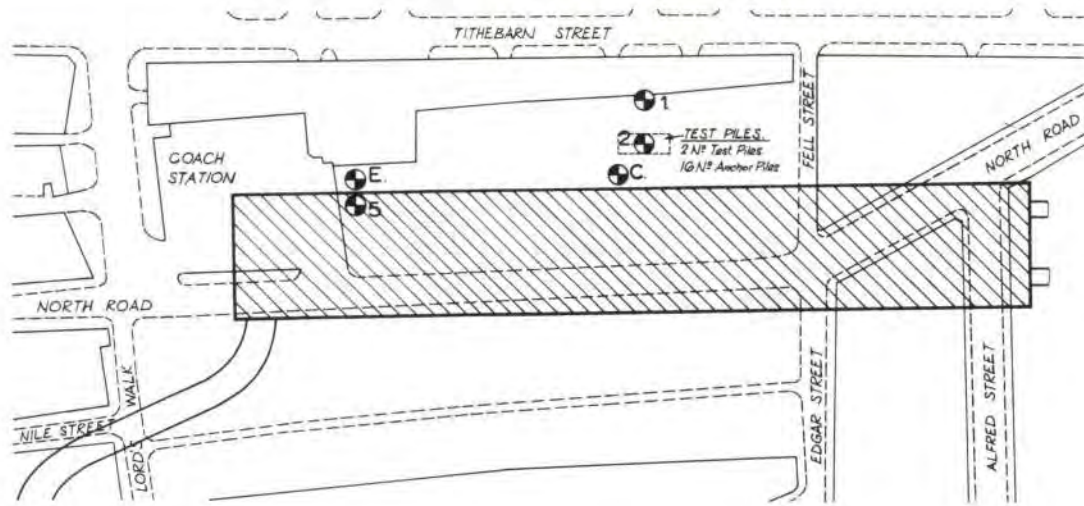
BOREHOLE 'C'			
STRATA	LEGEND	DEPTH	N
Cinder & brick fill	[Cross-hatch pattern]	G.L.	
Light brown fine sand with thin bands of silt & gravel	[Dotted pattern]	4' 0"	
			10
			8
		26' 6"	7
Loose light brown silt	[Cross-hatch pattern]	2	
		33' 0"	
Firm brown clay. Compact light brown sand.	[Horizontal lines]	34' 0"	23
Dense fine light brown sand	[Dotted pattern]	37' 6"	40
		46' 6"	40
End of borehole

BOREHOLE '1'			
STRATA	LEGEND	DEPTH	N
Made ground—ashes, brick, rubble, sand.	[Cross-hatch pattern]	G.L.	
Loose fine silty sand	[Dotted pattern]	2' 6"	4
Moderately compact reddish brown medium grained sand with occasional fine gravel	[Dotted pattern]	7' 0"	16
			17
			13
			23
		29' 0"	13
Fine silty sand. Moderately compact to compact reddish brown fine sand	[Dotted pattern]	31' 0"	17
			21
			34
			22
		47' 0"	80
Very compact fine reddish brown sand	[Dotted pattern]	50' 0"	50
End of borehole

BOREHOLE 'E'			
STRATA	LEGEND	DEPTH	N
Brick clay & cinder fill	[Cross-hatch pattern]	G.L.	
Compact light brown sand	[Dotted pattern]	4' 0"	
			9
		23' 0"	7
Loose light brown sand with bands of soft brown clay	[Dotted pattern]	2	
		3	
		38' 0"	2
Dense light brown sand	[Dotted pattern]		41
			42
End of borehole		51' 6"	46

BOREHOLE '5'			
STRATA	LEGEND	DEPTH	N
Made ground ashes, brick, rubble, sand. Dark grey silty sand. Moderately compact mixed brown sand with occasional gravel	[Cross-hatch pattern]	G.L.	
		1' 6"	
		3' 6"	13
			14
			14
			13
Loose fine brown silty sand	[Dotted pattern]	21' 0"	9
			8
			11
Compact becoming very compact with depth. Fine to medium brown sand	[Dotted pattern]	36' 0"	29
			35
			50
End of borehole		50' 0"	63

Boreholes 'C' & 'E' by Geo-Research Ltd, 1966.
Boreholes '1', '2' & '5' by G.K.N. Foundations Ltd, after test piles installed.

Before commencing the installation of the working piles, GKN did five boreholes of their own for their own use. Two of these, no. 1 and no. 2, were adjacent to the test pile set up, no. 1 being about 20 ft. (6.1 m) away from it and no. 2 being between the test piles. GKN borehole no. 5 was close to Geo Research borehole E. The logs of these holes, and SPT (Standard Penetration Test) values obtained from them, are shown in Fig. 7.

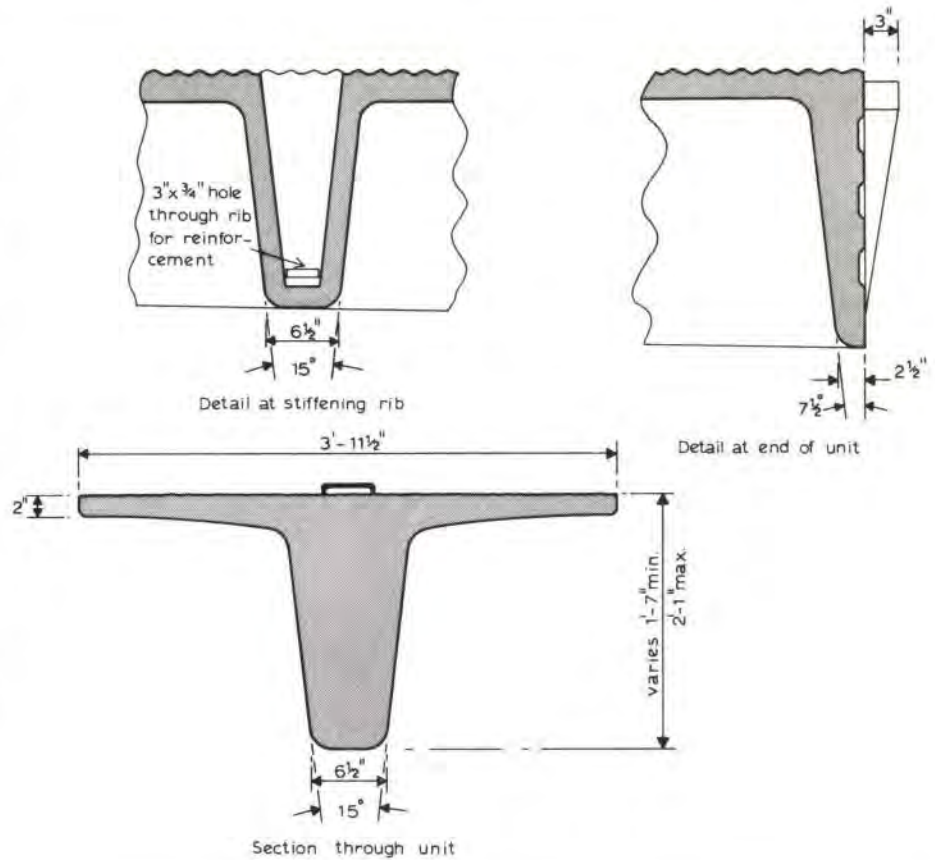
Fig. 8 right

Details of precast units.

There are five precast unit types, A, B, C, D and E, and details of these are shown in Fig. 8 and Table 3. Each type has variations to accommodate services, fixings and reinforcements, but none of the variations affect the basic moulds.

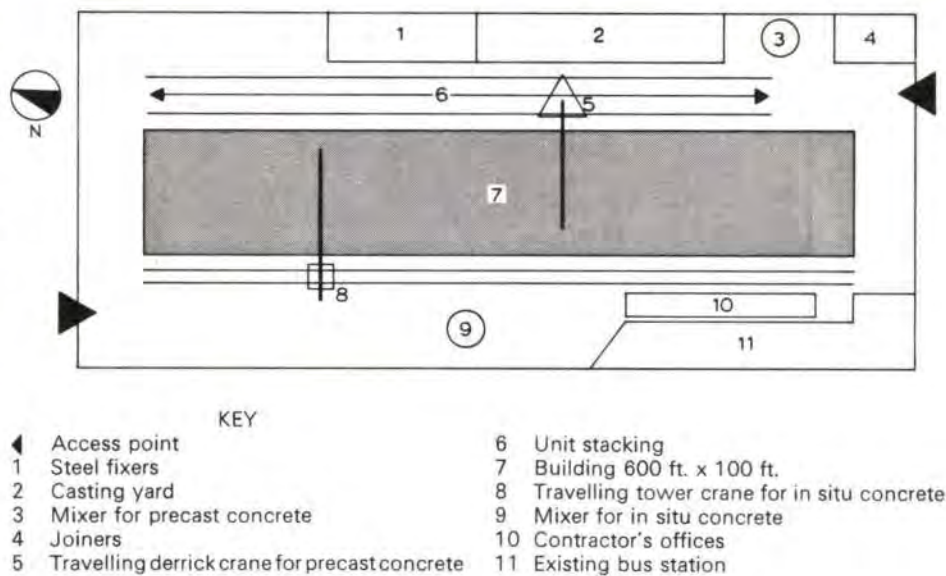
Fig. 9
Layout of contractor's plant.

The timber formers for the moulds were made in Blackpool by Messrs. Glasdon Signs Ltd. and the fibre glass moulds were made in Nelson by Bennett Plastics Ltd. Thirty moulds were made in all, 12 of type A, 1 each of nos. B, C and D and 15 of type E, and these were then set up in the site casting yard by the contractor (Fig. 9).

The finish to the top of the flange is produced by wire brushing the green concrete in the direction of the flange width to produce a surface suitable for keying the in situ topping. In addition to this key there are depressions in the flange edges and projecting links from the web (Fig. 9).

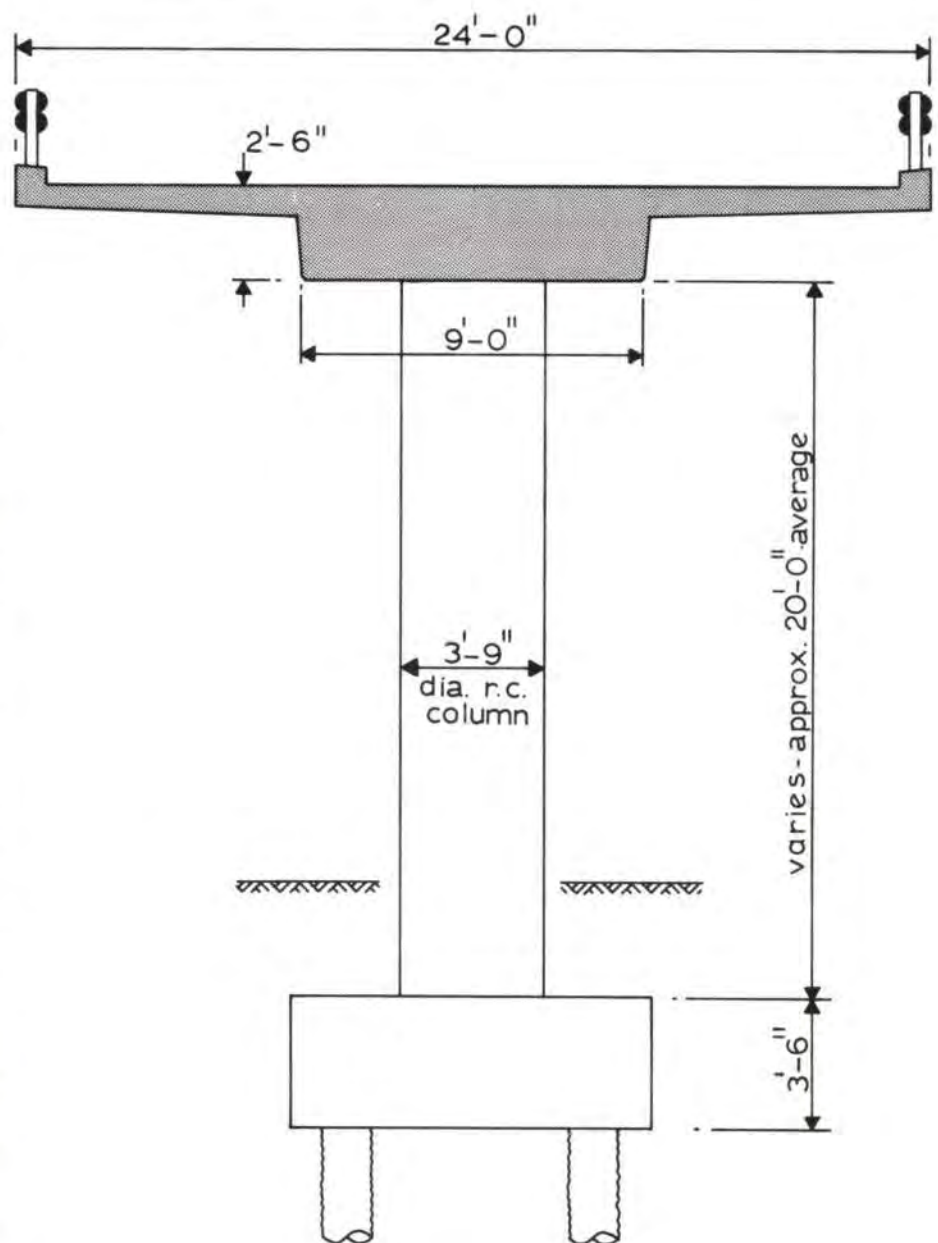
Fig. 10
Section through ramp.

The ramps are of in situ construction with decks supported on single rows of circular columns. The finish to the decks is fair faced concrete but the columns are grit blasted. At the southern end of the car park the ramp is 24 ft. (7.3 m) wide, allowing two way traffic. At this end, the deck spans are up to 44 ft. 6 in. (13.5 m) across 3 ft. 9 in. (1.1 m) diameter columns and the spine beam is 2 ft. 6 in. (760 mm) deep overall by 9 ft. (2.7 m) wide, with the deck slab cantilevering either side and tapering in thickness from 10 in. (250 mm) to the edge (see Fig. 10). The edge thickness is 1 ft. 1 in. (330 mm) of which 7 in. (180 mm) is taken up by the deck slab, the remaining 6 in. (150 mm) being a kerb. At the northern end the ramps are 12 ft. (3.7 m) wide with spans up to 35 ft. (10.7 m). These are of lighter construction than the northern ramp but of similar shape.

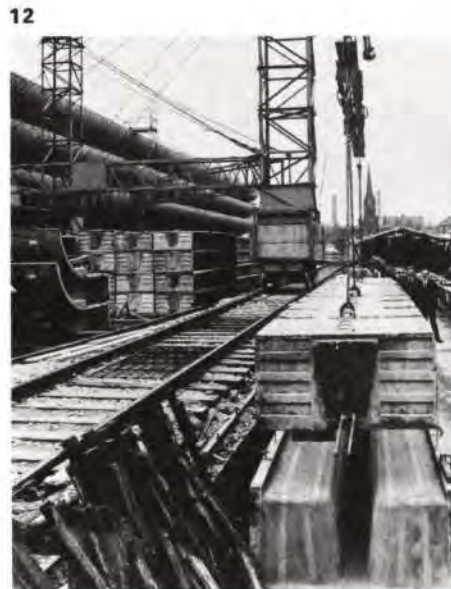
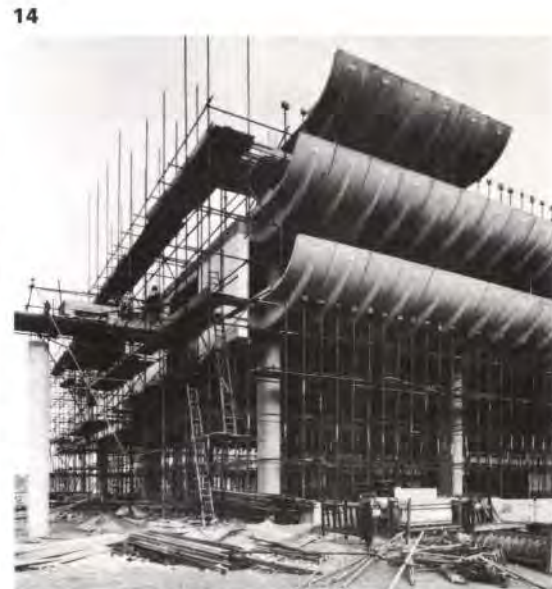
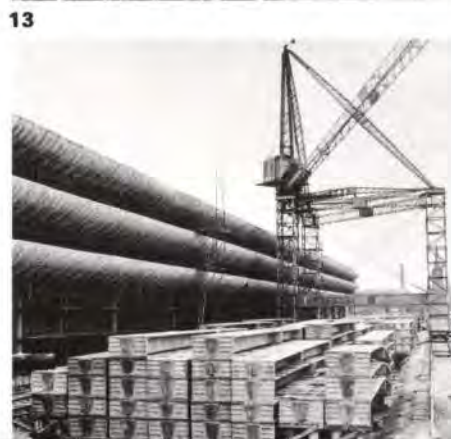
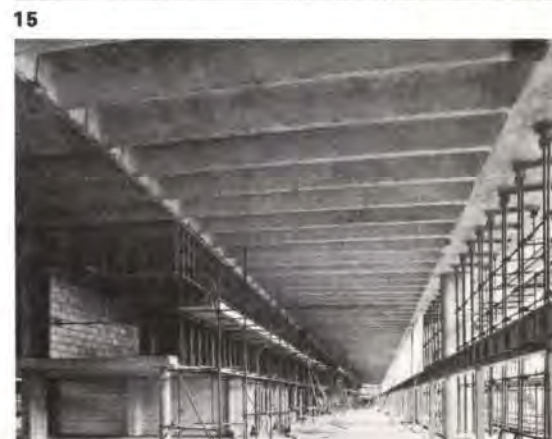
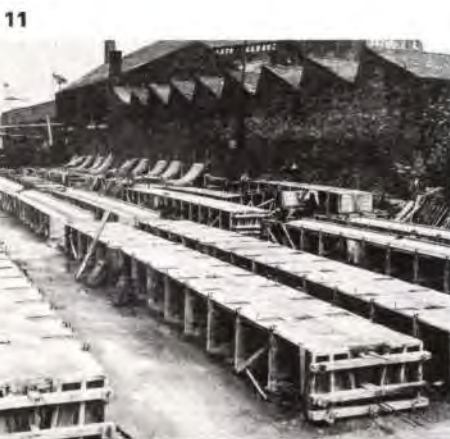
Fig. 12
Type A unit being de-moulded.
(Photo: Geoff Howarth)

Fig. 13
Stacking yard on east side of building.
(Photo: Geoff Howarth)

Fig. 14
North-west corner,
exit ramp and tiled cladding.
(Photo: Arthur Winter)

Fig. 15
Inside the concourse
during construction.
(Photo: Arthur Winter)

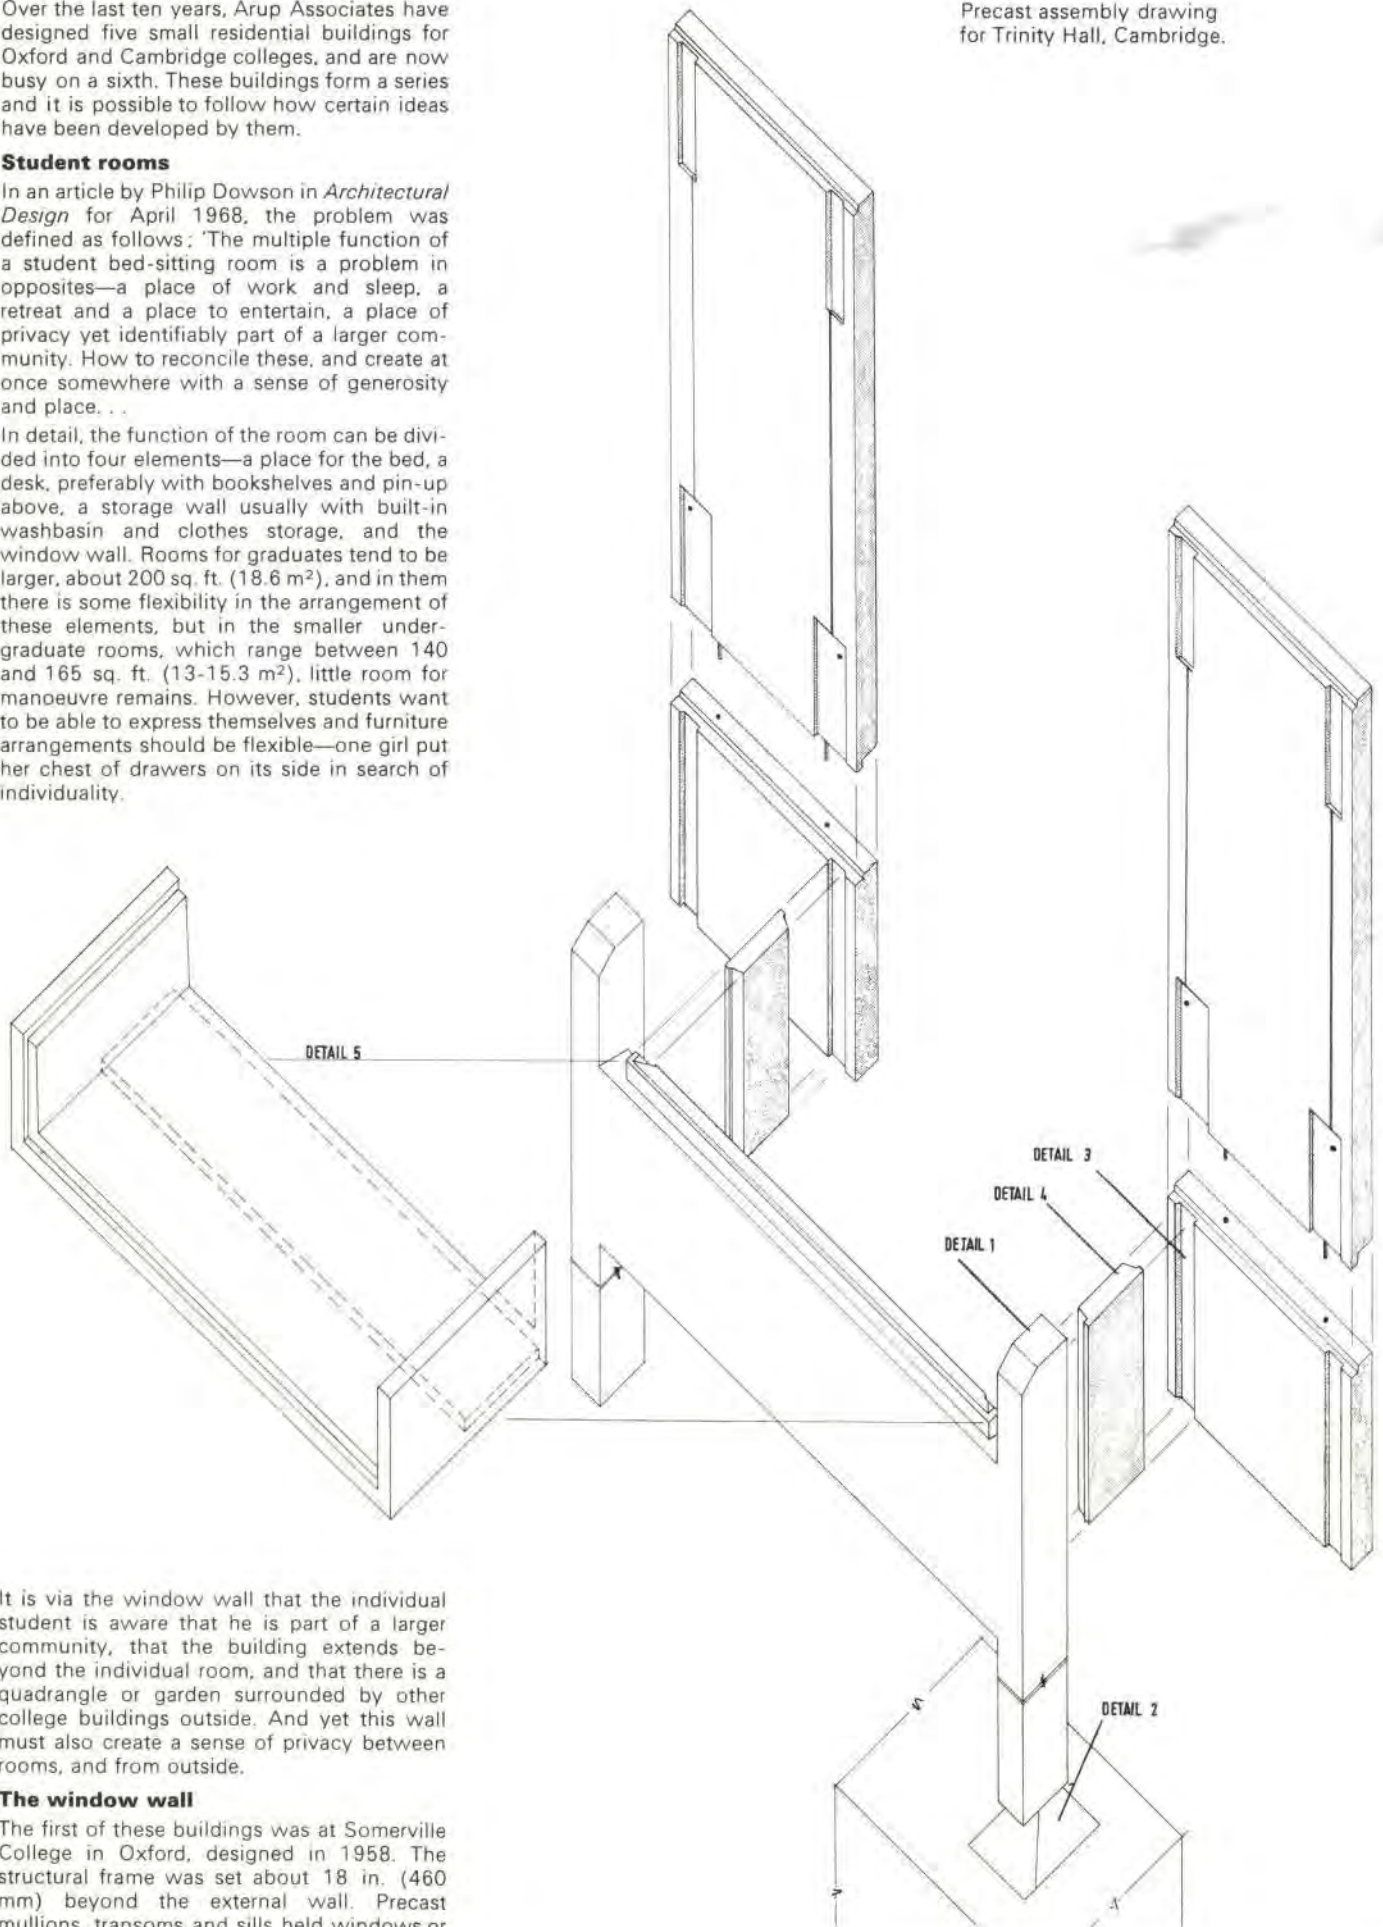
Fig. 1

Precast assembly drawing for Trinity Hall, Cambridge.

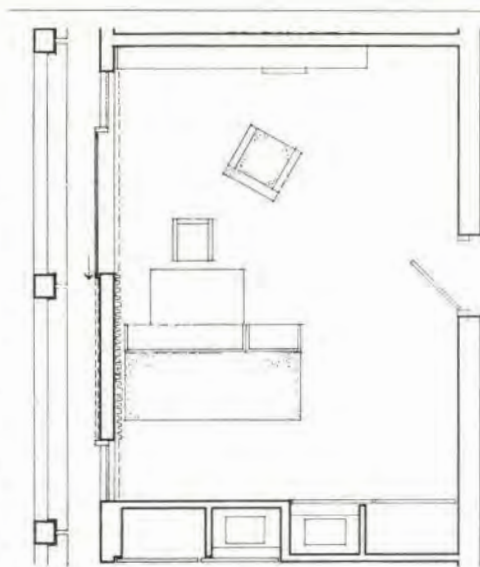
Fig. 14 Somerville College, Oxford, stages I and II.

The first of these buildings was at Somerville College in Oxford, designed in 1958. The structural frame was set about 18 in. (460 mm) beyond the external wall. Precast mullions, transoms and sills held windows or precast panels. Above the transoms was a

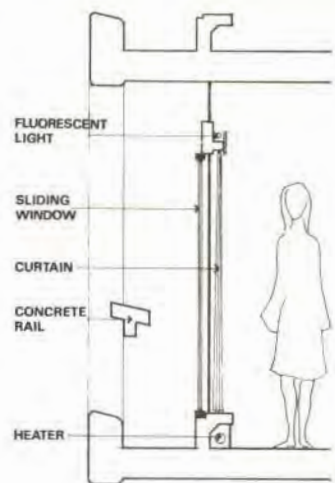
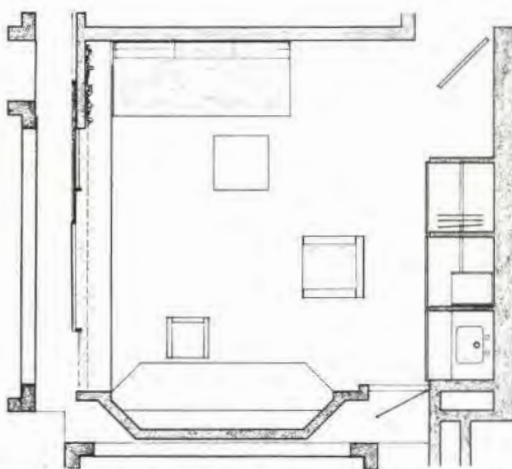
Fig. 15 Corpus Christi, Cambridge, Leckhampton House.

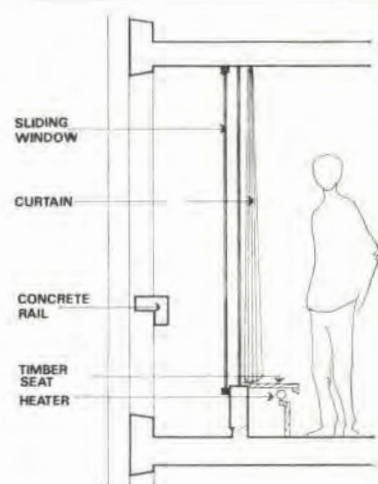
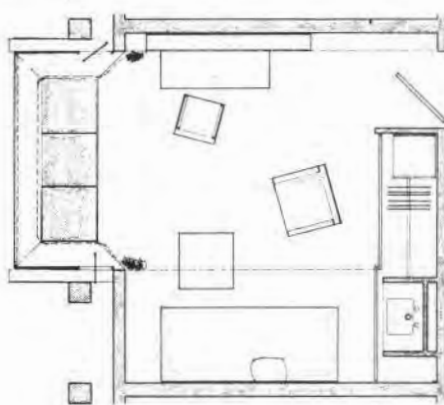
Fig. 16 Somerville College, Oxford, stage III, Wolfson Building.

This idea of modulating the external wall in relation to the external frame was carried further in the next building, which was the Wolfson Building, back at Somerville College (1964). In both the previous buildings, with the external wall running parallel behind the frame, the fenestration pattern was apparently arbitrary. However the same sense of the building extending beyond the individual room could be achieved if the windows were pushed out beyond the frame, instead of pulled back behind it. Also there were obvious gains to the room in having a large window seat, which was an admired tradition in the older buildings of the university. Although all the previous buildings had had common rooms at ground level, here for the first time was the need for a column-free multi-purpose hall, and consequently a clear span. This was achieved by the introduction of precast post-tensioned concrete beams spanning across the building, with the bay windows fixed between them.

Only the sides of the bay open, so as to retain a sense of security when one sits amongst the columns and beams beyond the building. This also has the effect of turning the focus of the window seat back into the room. The introduction of beams added almost 2 ft. (610 mm) to the height of the room, which provided an opportunity to create a bed alcove with the ceiling over it dropped to the soffit of the beam. It did, however, let much more light into the rooms than we had anticipated, with a consequent loss of privacy, unless the blinds were down.

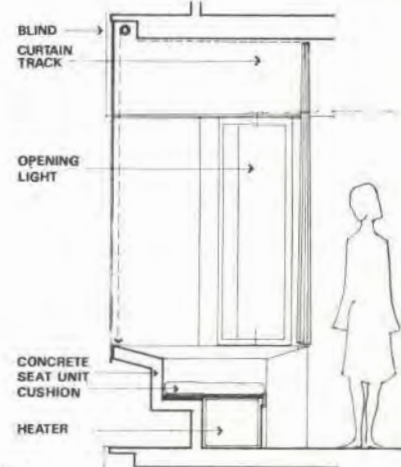
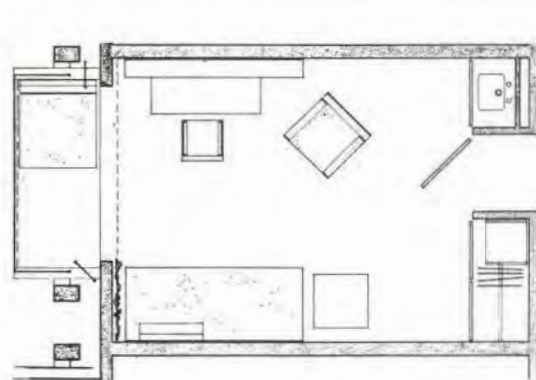
Fig. 17 Trinity Hall, Cambridge, Wychfield House.

Trinity Hall (1966), we have tried to simplify the details. The common room at ground level could accept internal columns, so the structure reverts to a flat slab spanning over the internal columns and out to the beams of the external frame. The tops of the bay windows were made of sloping glass, with the sun blind pulling down this slope over a relieving roller, and then down the vertical face. With the ventilation coming from the sides of the bay, it is possible to have both sun shading and ventilation at the same time. The fan convectors have been positioned under the clothes cupboard on the back wall of the room. A rail across the window acts as both a back rest and a small electric heater (250w). The latter is incorporated to cope with down draughts and condensation.

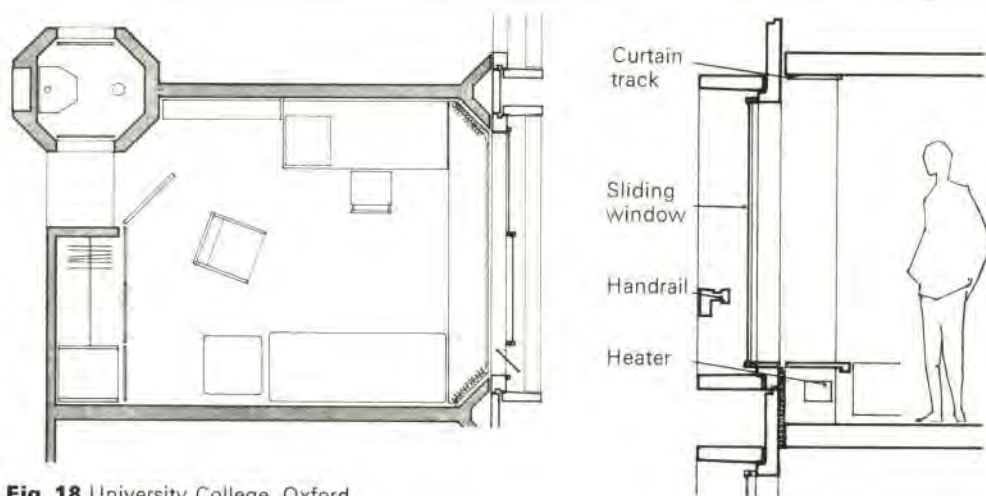
Fig. 18 University College, Oxford.

We are now working on a sixth building for University College, Oxford (1969). Here there is no common room, and so the justification for a framed structure is removed. Sound insulation between rooms is vital, so that there is much in favour of a cross-wall solution which combines the needs of structure and sound insulation. Naturally the structural change greatly reduces the number of elements of the external wall, by the omission of structural members. Two elements remain; panels and window units. The latter are designed to provide many of the solutions arrived at in the earlier buildings, privacy by their projecting sides, an enhanced quality of daylight by their projecting head and sill, outlook down into the garden combined with the security provided by an external handrail, a housing for the heating element which is back under the window and grooves to carry windows, glazing, curtain tracks, etc.
